Upper Deschutes River Bank Stability Characterization

August 2002

Kolleen Yake, Watershed Assessment Manager, Upper Deschutes Watershed Council
PO Box 1812, Bend Oregon 97709

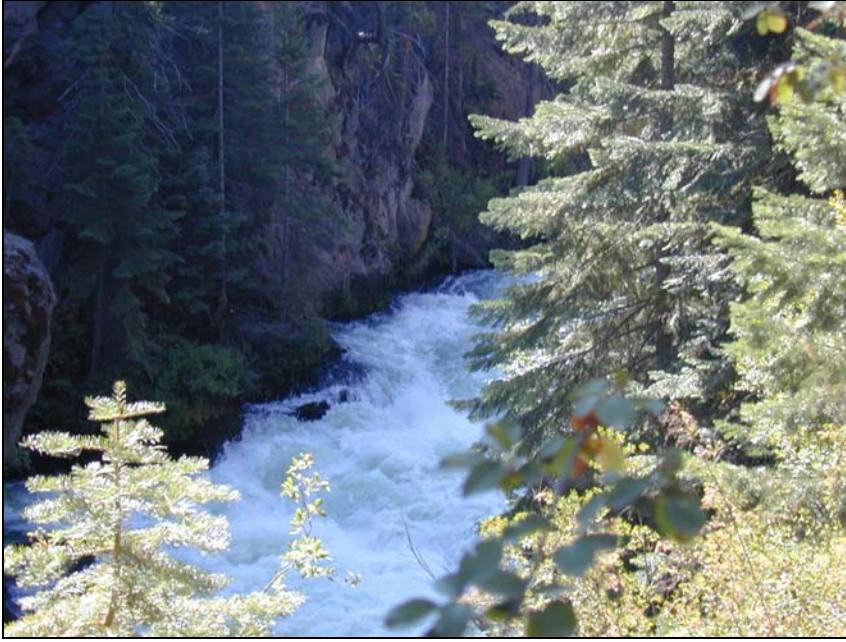
Photograph 1: Reach 104, Benham Falls

As mentioned in the introduction, some sections of the Upper Deschutes are naturally resistant to erosion due to the geology of the area. Taken from the overlook at Benham Falls, photograph 1 displays the bedrock that is remnant from the Lava Butte Flow from the eruption of Newberry Volcano. The lava rock remains and lines the channel at Benham Falls. Although the gradient and velocity are high in this reach, the erosion potential is very low.

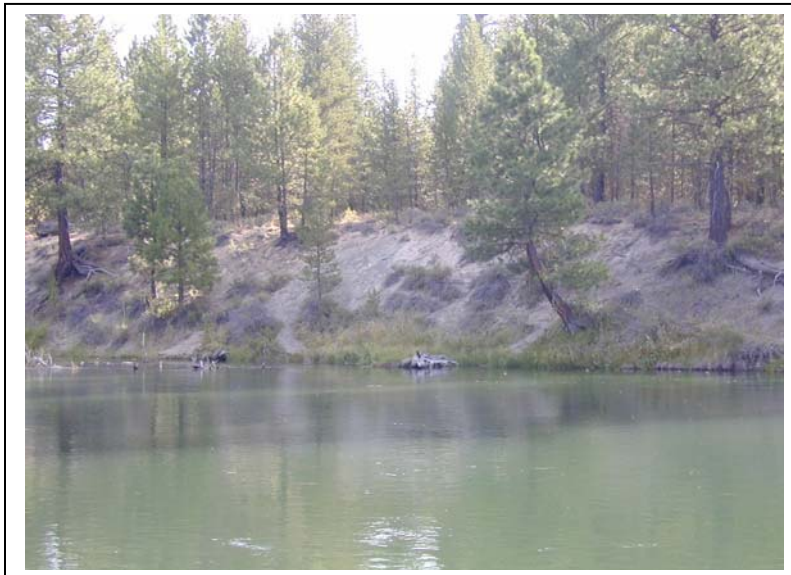
Photograph 2: Reach 51, La Pine State Park

Distinctly different from the banks at Benham Falls, the stream reach in photograph 2 consists of primarily silt and clay fine sediments. This reach is located at river mile 209 near La Pine State Park. The bank received a BEHI rating of moderate due to the combination of loose bank materials, moderate vegetation, and a 45 degree bank angle. The sedges and other herbaceous material at the water's edge combined with some surface protection from the pine roots to prevent a higher erosion rating.

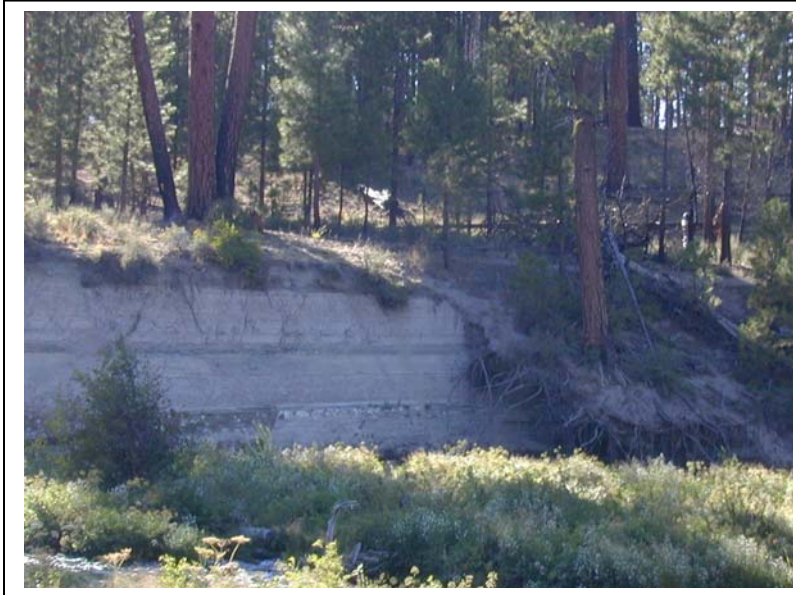
Photograph 3: Reach 30, Tetherow Log Jam

Taken just below river mile 213, photograph 3 presents a stream bank that received a BEHI rating of extreme. On this bank there is vegetation at the top portions of the bank

but it is serving no protective service to the erosion or erodability of the bank at the water's edge.

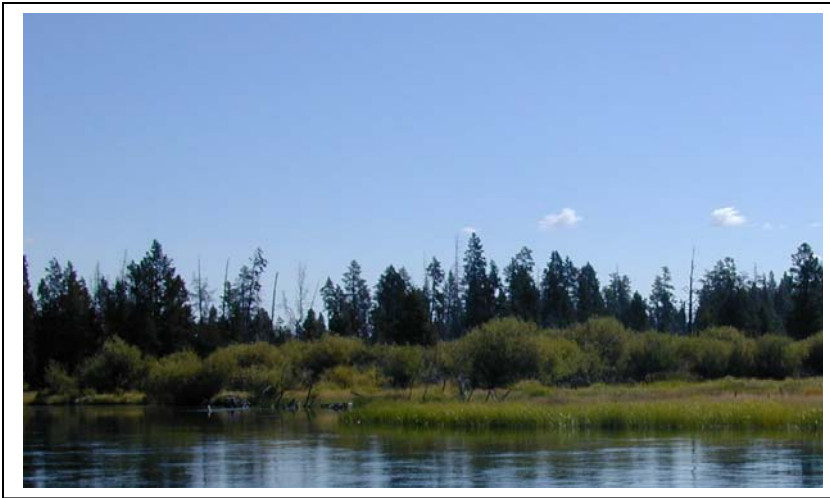
Photograph 4: Reach 62, Fall River Area

The relatively small number of banks receiving a very low BEHI rating is due to the fact that a large percentage of the banks that appeared to have no erosion problem were not included in the assessment. Reach 62 shown in photograph 4 is a bank that was assessed in order provide a representative sample of banks that, due to high levels of surface protection and low height, have very low or no erodability potential. Photograph 4 is representative of the majority of inside meander bends on the Upper Deschutes. As in the photo, the inside of meanders were typically deposition areas that had well established sedge meadow and willow vegetation.

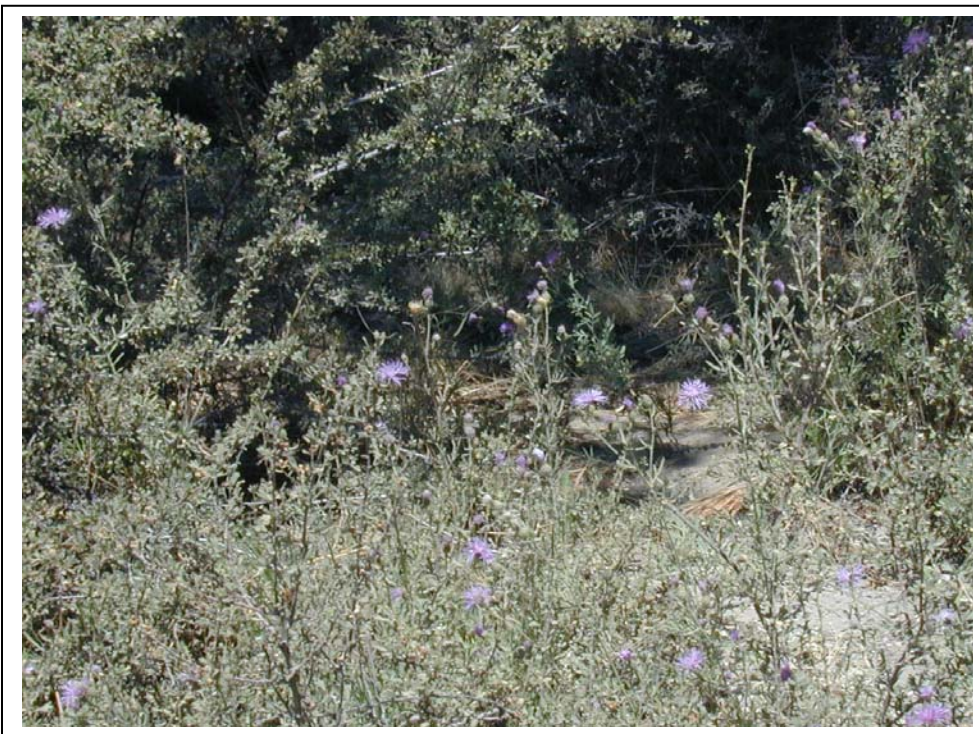
Photograph 5: Reach 108, ¼ mile downstream from Slough campground

Photograph 5 shows a substantial patch of knapweed located right on the river trail. This patch of knapweed is between the trail and the water's edge. As knapweed sends down a single deep taproot, the weed can exacerbate erosion but edging out other native riparian vegetation that would more effectively hold soil in place.

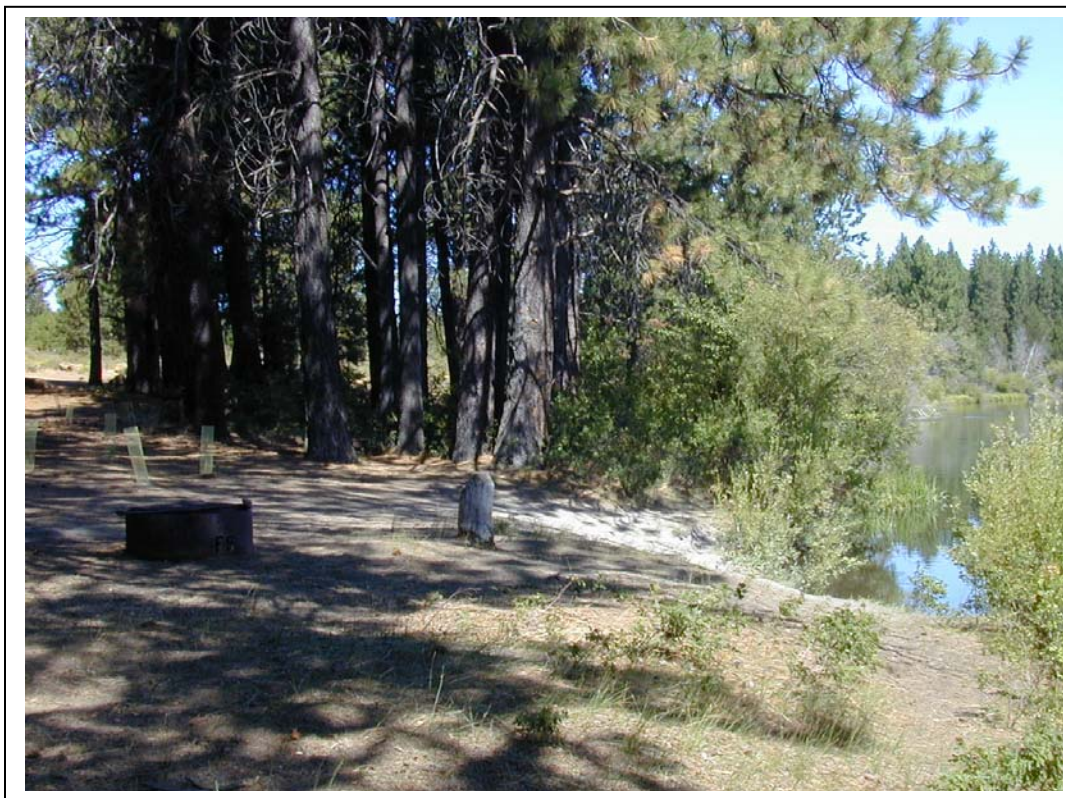
Photograph 6: Reach 107, Slough

Photograph 6 was taken at Slough campground near river mile 180. There is an overnight campground, a dirt road, and a boat launch located here and the river trail runs from Bend up through the campground. Although the campground receives high levels of use, the erosion is low. The low erosion is probably due to low bank heights and lower water velocity.
