**Upper Deschutes Watershed Council
Technical Report**

2016 Camp Polk Monitoring Report

**Upper Deschutes Watershed Council
Bend, OR
February 2017**

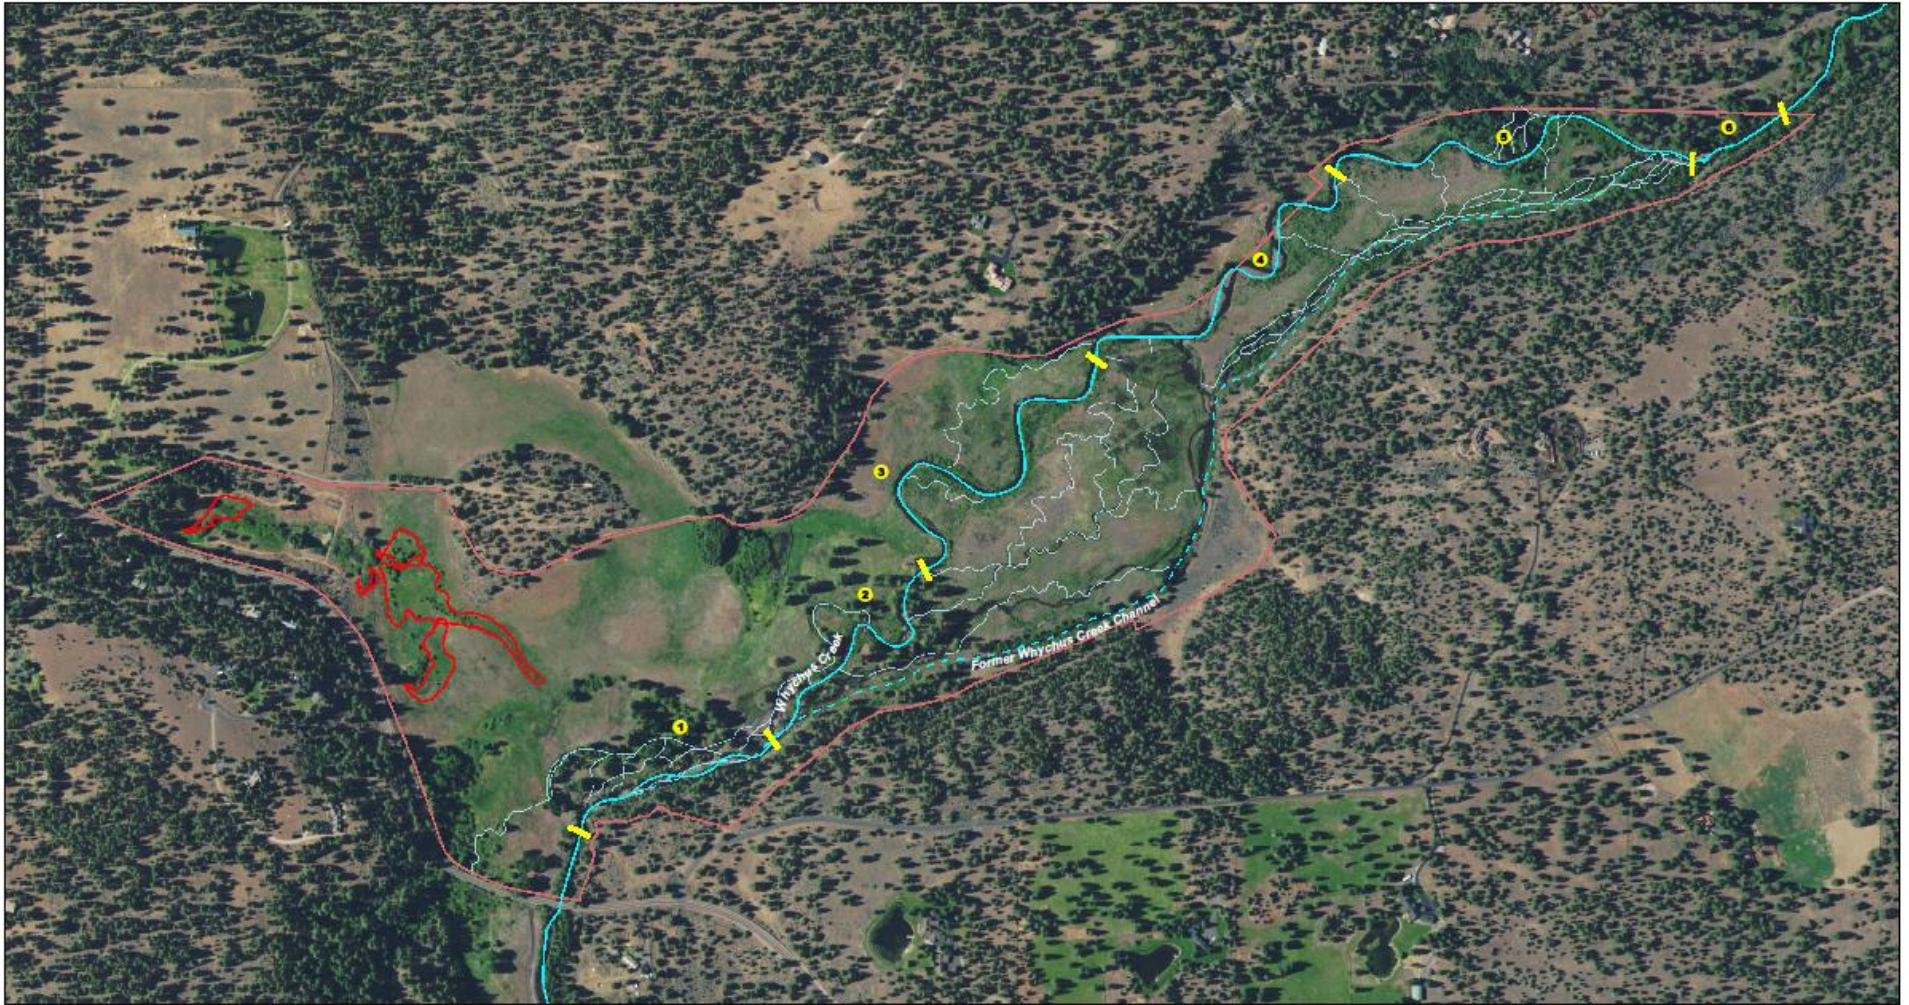
APPENDIX E. 2016 weed treatments at Camp Polk Meadow

Camp Polk Meadow: Canada Thistle treated in 2016

Management actions in 2016 continued to include hand-pulling and clipping of spotted knapweed, mullein, and bull thistle. The Canada thistle and common teasel populations treated in 2015 demonstrated improvements. One small, isolated population of Canada thistle to the west of the main populations exhibited very little re-emergence in 2016 and therefore was not re-treated. Canada thistle and teasel continued to flourish in areas of saturated soils and near water where DLT had not treated in 2015 due to restrictions specific to the herbicide used. Accordingly, in 2016 DLT treated dry areas with Opensight as in 2015, and treated populations growing in saturated soils with an aquatic version of 2,4D (Appendix E). DLT weed monitoring efforts in 2017 will focus on determining the efficacy of recent herbicide treatment strategies, adjusting treatment strategies, and re-treating remaining populations as funding permits. They will continue with hand-pulling, concentrating the majority of the hand-pulling efforts on mullein in the restoration area.
