**Upper Deschutes Watershed Council
Technical Report**

2018 Camp Polk Monitoring Report

**Upper Deschutes Watershed Council
Bend, OR
June 2019**

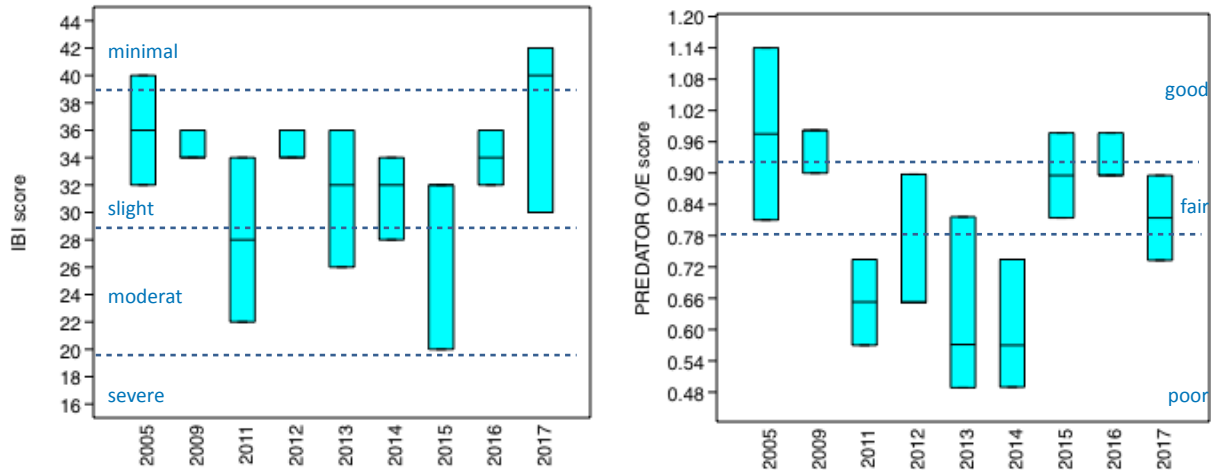
Figure 1. IBI and PREDATOR scores at sites WC1825-WC1900. Horizontal line in each box indicates median value; filled box shows interquartile ranges; whiskers depict data range. Dotted lines show transitions points for biological condition scores.

Mean PREDATOR scores tracked mean IBI scores (Figure 1). Lower mean scores from 2011-2014 suggested poor biological conditions; mean scores from 2015 to 2017 corresponded to fair, and, in 2016, good biological conditions. Mean scores were significantly different for some years; the 2014 mean score indicating poor conditions was significantly lower than 2005 and 2009 means indicating good conditions, and the 2013 mean score was significantly lower than the 2005 mean score and close to significantly lower than the 2009 mean score. While predictive models such as PREDATOR are often considered more sensitive and accurate than IBIs, on Whychus PREDATOR scores correlate poorly with IBI scores (Pearson’s $r = 0.203$), bringing into question how well the parameters of this model describe the Whychus system. While we continue to use the PREDATOR model as one method to evaluate macroinvertebrate community data, we place greater confidence in metrics that more directly reflect a biological response to stream conditions.

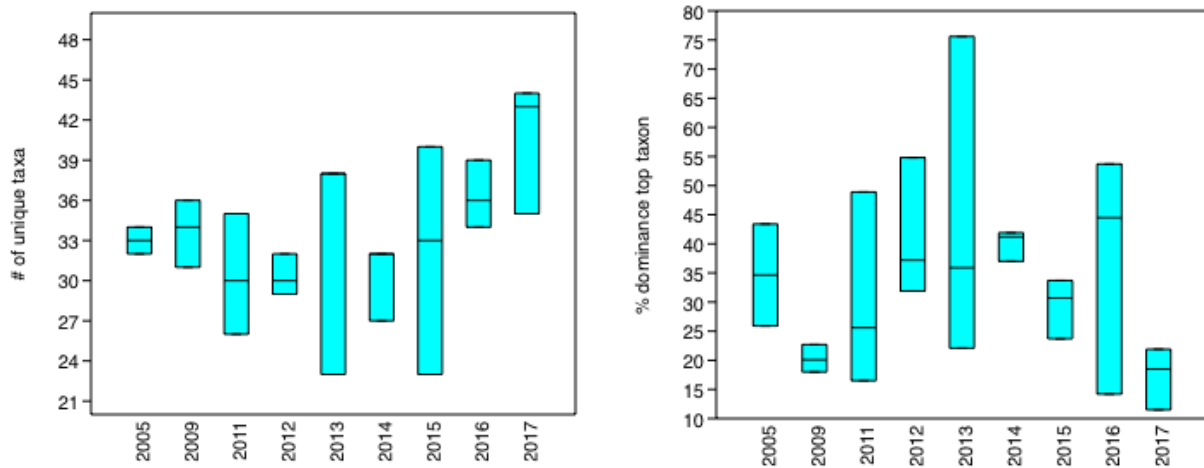
Figure 2. Diversity and % dominance of the most abundant taxon at sites WC1825-WC1900. Horizontal line in each box indicates the median value; filled box shows interquartile ranges; whiskers depict data range.

Mean richness (number of unique taxa) and mean dominance of the most abundant taxon for the three sites both support the trend indicated by IBI and PREDATOR scores (Figure 2). Mean richness decreased slightly from 2005 to 2014 and increased from 2015-2017, with 2017 characterized by the highest number of taxa observed at the three sites to date. Mean dominance of the most abundant taxon, a negative metric (higher scores indicate worse conditions), increased from 2011 through 2014 and decreased from 2014 through 2017. Means were not significantly different among years for either metric. The number of caddisfly taxa increased from 2005 through 2017, and the number of mayfly taxa increased significantly from 2014 to 2017 (Figure 3).

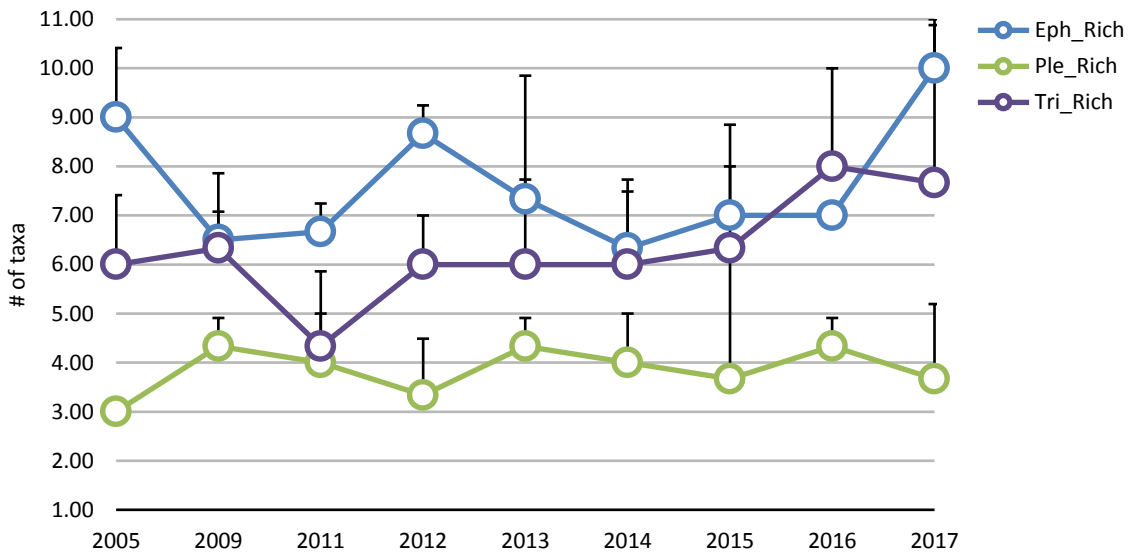
Figure 3. Mean diversity of mayflies (Eph_Rich), stoneflies (Ple_Rich) and caddisflies (Tri_Rich) at sites WC1825-WC1900. Vertical bars show standard deviation.

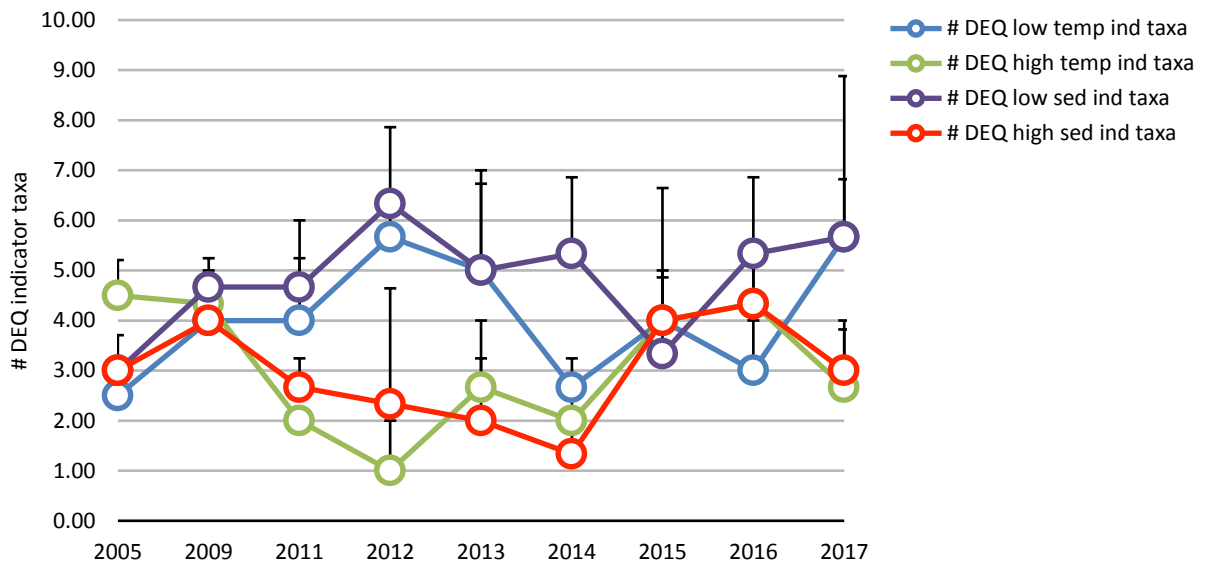
Figure 4. Mean numbers of DEQ temperature and sediment indicator taxa at WC1825-WC1900. Vertical bars show standard deviation.

The mean number of DEQ low temperature indicator taxa and low sediment indicator taxa generally tracked each other, increasing through 2012, decreasing between 2014 and 2016, and increasing to match 2012 numbers in 2017 (low sediment indicator taxa decreased only in 2015) (Figure 4). This pattern also follows the trend observed from other metrics indicating improving conditions through 2012, declining from 2012 to 2014 or 2015, and improving between 2015 and 2017. The decrease in low

temperature indicator taxa in particular corresponds to a 2014-2016 increase in high temperature and sediment indicator taxa (both fell to or below 2005 numbers in 2017). The mean number of low temperature indicator taxa was significantly higher in 2017 than in 2005 and 2014.

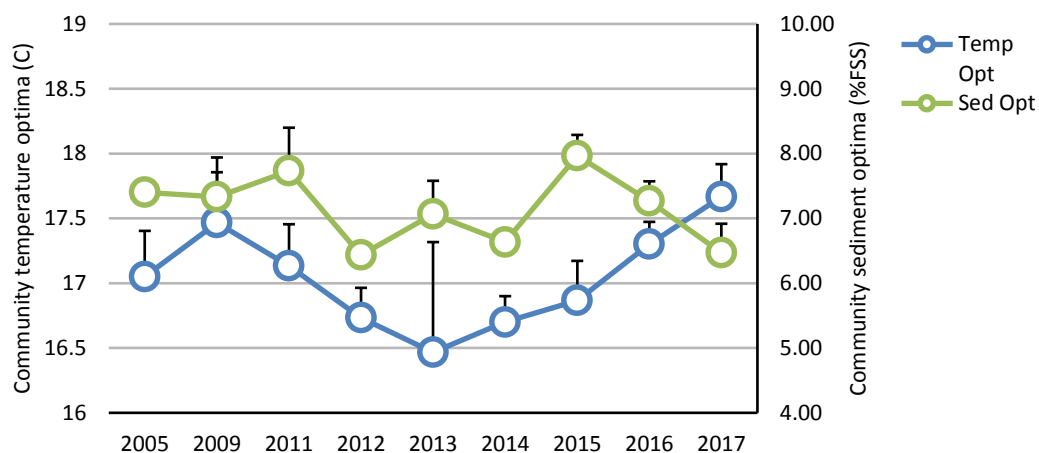
Figure 5. Mean community temperature and sediment optima at WC1825-WC1900. Vertical bars show standard deviation.

Unlike other community metrics, community temperature optima decreased through 2013, but has steadily increased since 2013 (Figure 5). This trend, consistent across all Whychus Creek macroinvertebrate sampling sites and more pronounced at mid-stream and upstream sites, may signal a response to larger climate stressors.

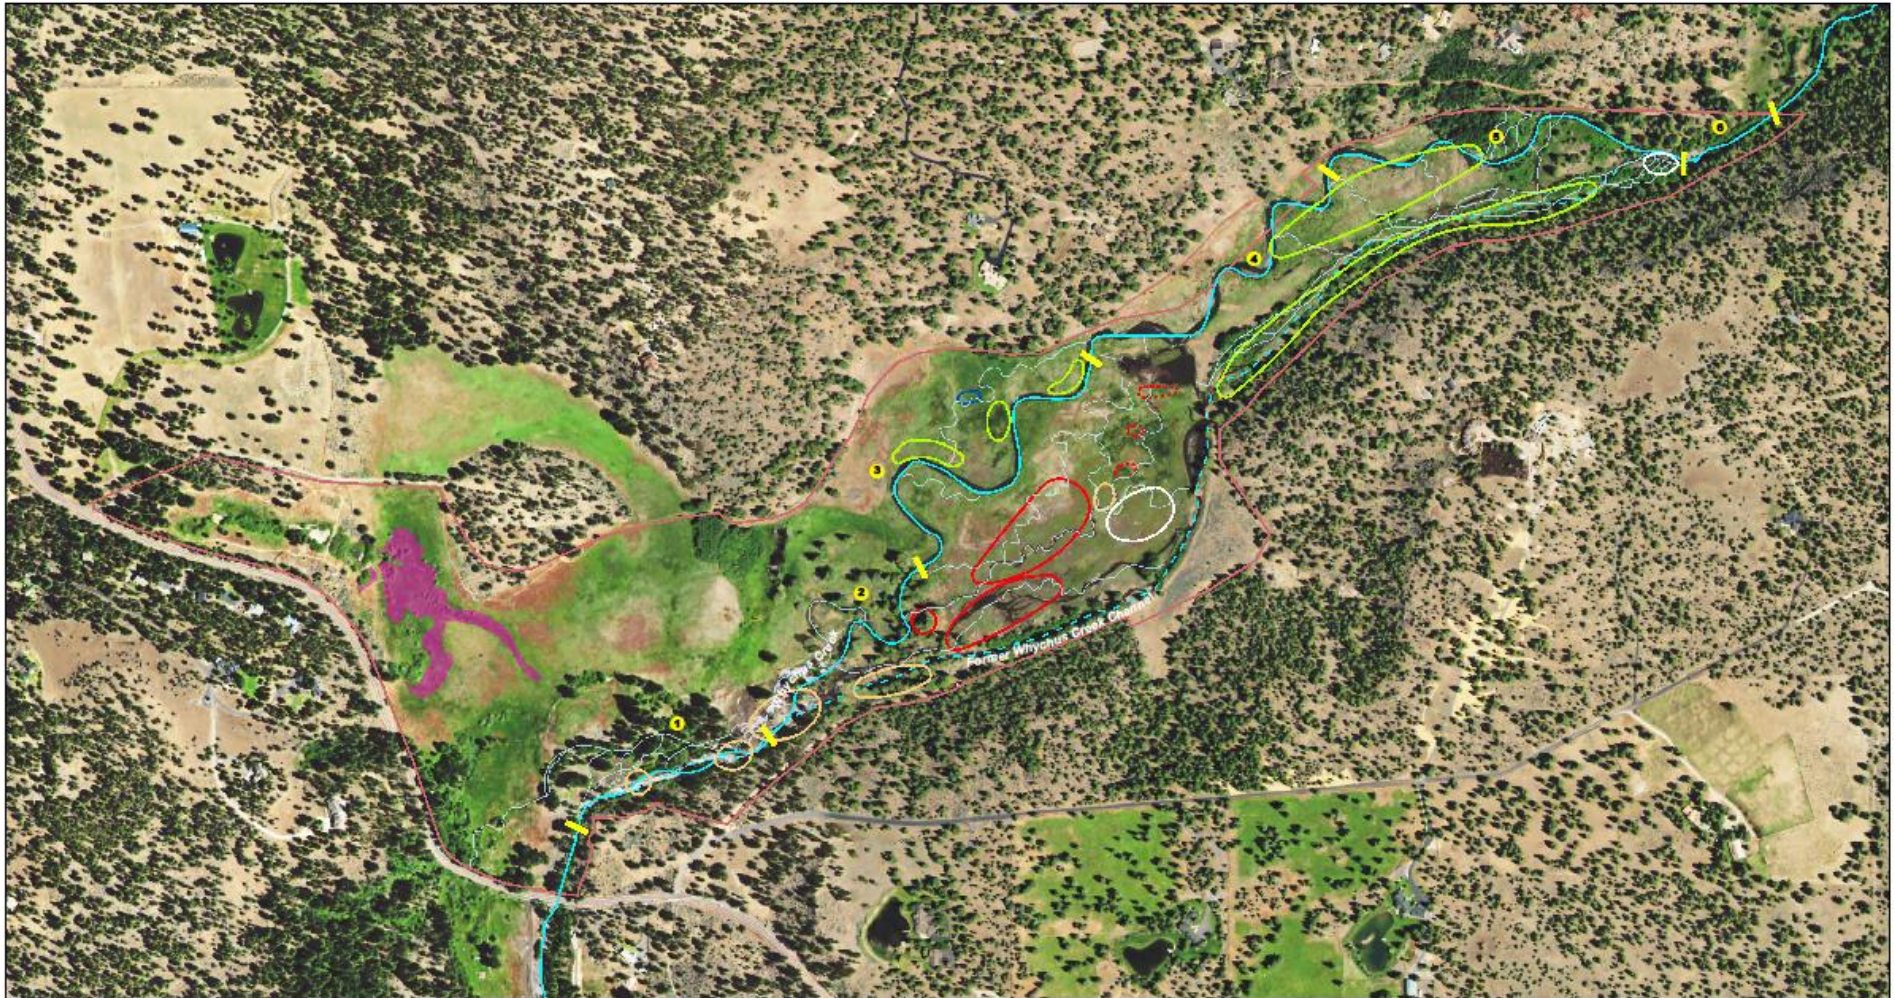
APPENDIX B. 2015 distribution of priority weed species of concern at Camp Polk Meadow.

2015 Weeds at Camp Polk Meadow Preserve

In addition to reed canarygrass mapping, weeds were surveyed and mapped in 2015 over four visits to the meadow, once per month from May through August (Appendix B; Appendix C). Species that continued to present a management concern as of 2015 included spotted knapweed, bull and Canada thistle, common mullein, and reed canarygrass. Spotted knapweed and bull thistle were found in sandbars, flood deposits, and dry side channels, suggesting that flood flows are likely introducing seeds of these species into the meadow. Common mullein also remained abundant throughout the restoration area. Volunteer crews hand-pulled (mullein) or clipped (knapweed and thistle) these species throughout the summer. Canada thistle continued to expand in the meadow despite sustained efforts to control it through clipping. In September 2015, DLT staff treated all major Canada thistle and co-occurring common teasel populations that could be safely treated with the herbicide Opensight (aminopyralid and metsulfuron methyl); additional treatments were anticipated to be needed in 2016 to control Canada thistle and teasel to the point where they can be controlled without the use of herbicides.

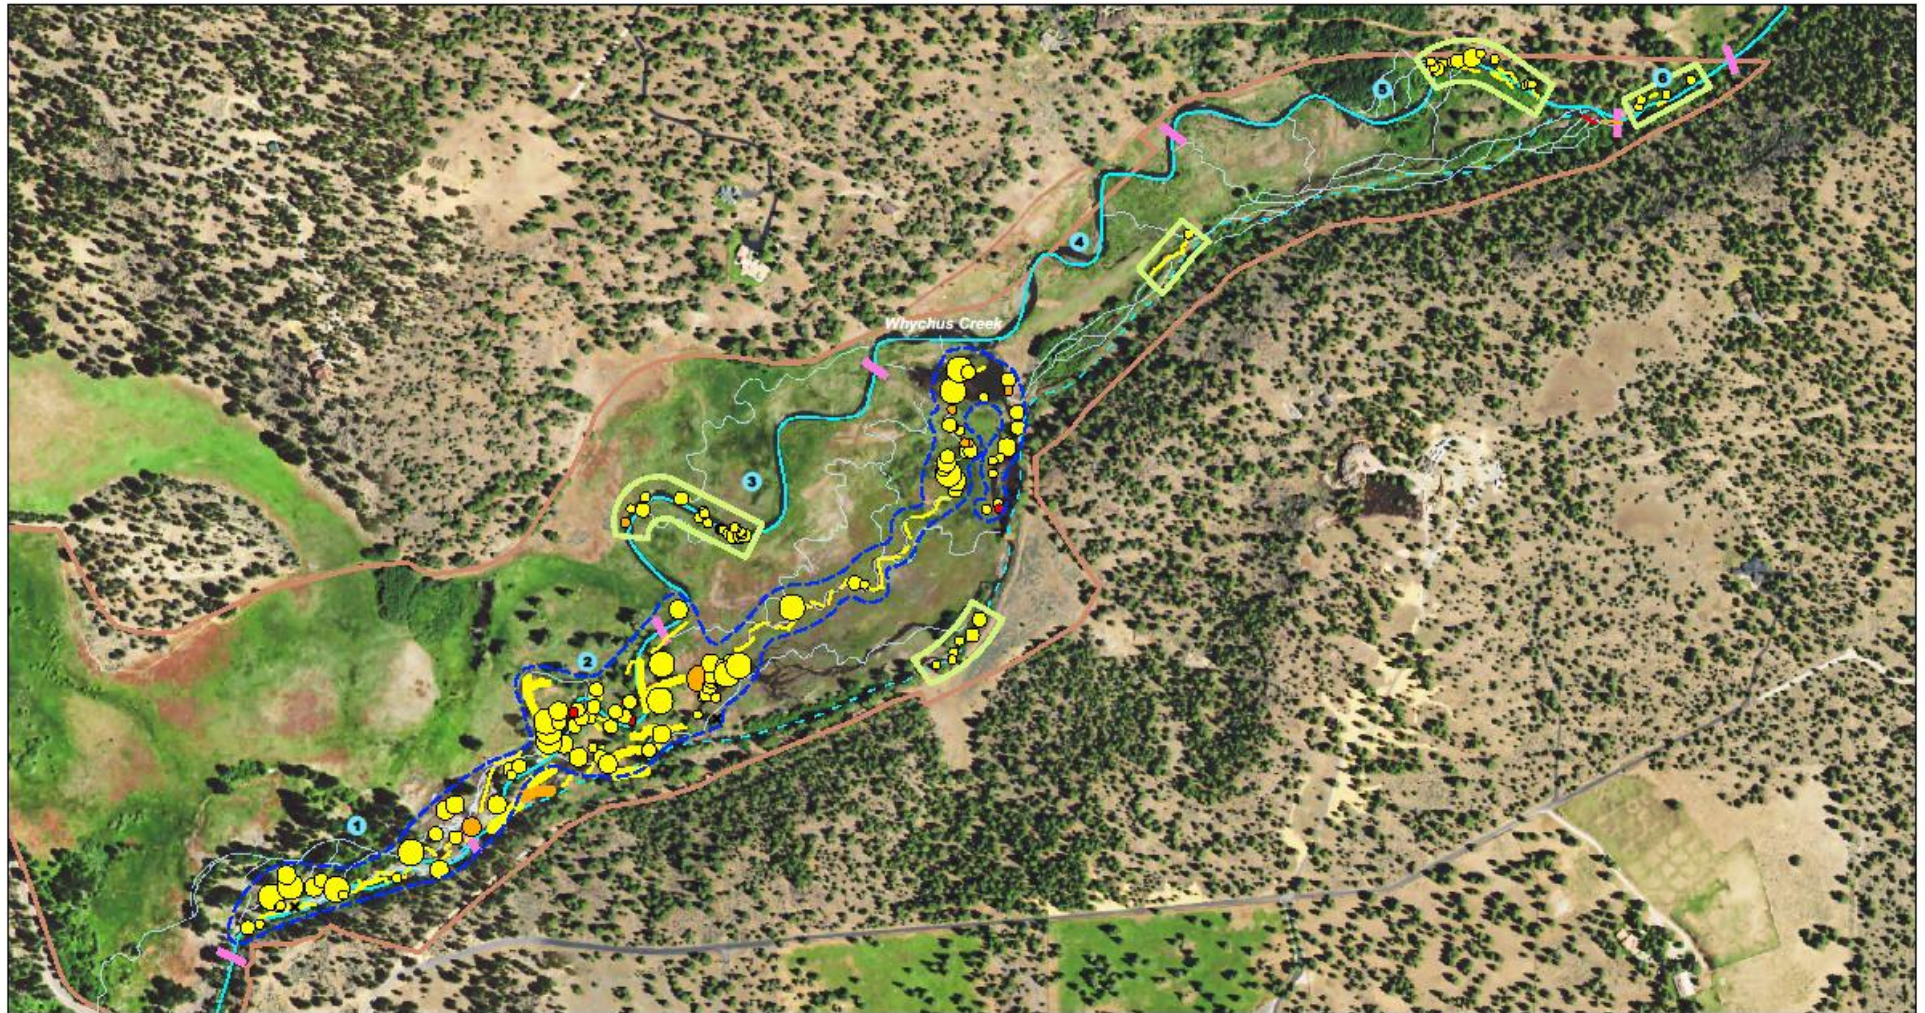
APPENDIX C. 2015 distribution of reed canarygrass at Camp Polk Meadow

2015 Reed Canarygrass at Camp Polk Meadow Preserve

To evaluate the scope and severity of RCG expansion and identify management alternatives for controlling RCG, in 2015 UDWC and DLT staff mapped reed canarygrass in the meadow, reviewed available literature on reed canarygrass ecology and management, and developed a preliminary plan for controlling reed canarygrass at Camp Polk. Sampling efforts were focused in the upstream reaches of the project (Reaches 1 & 2) and along the main channel and side channels (Appendix C). RCG was found at relatively low abundance (<25% cover) throughout areas sampled. It was consistently found in riparian areas and side channels where the stream accesses the floodplain during high flow events, leaving soil moisture high, and in stream channels where sediment and woody material collect. We did not find reed canarygrass in drier areas above elevations typically flooded by high flows.

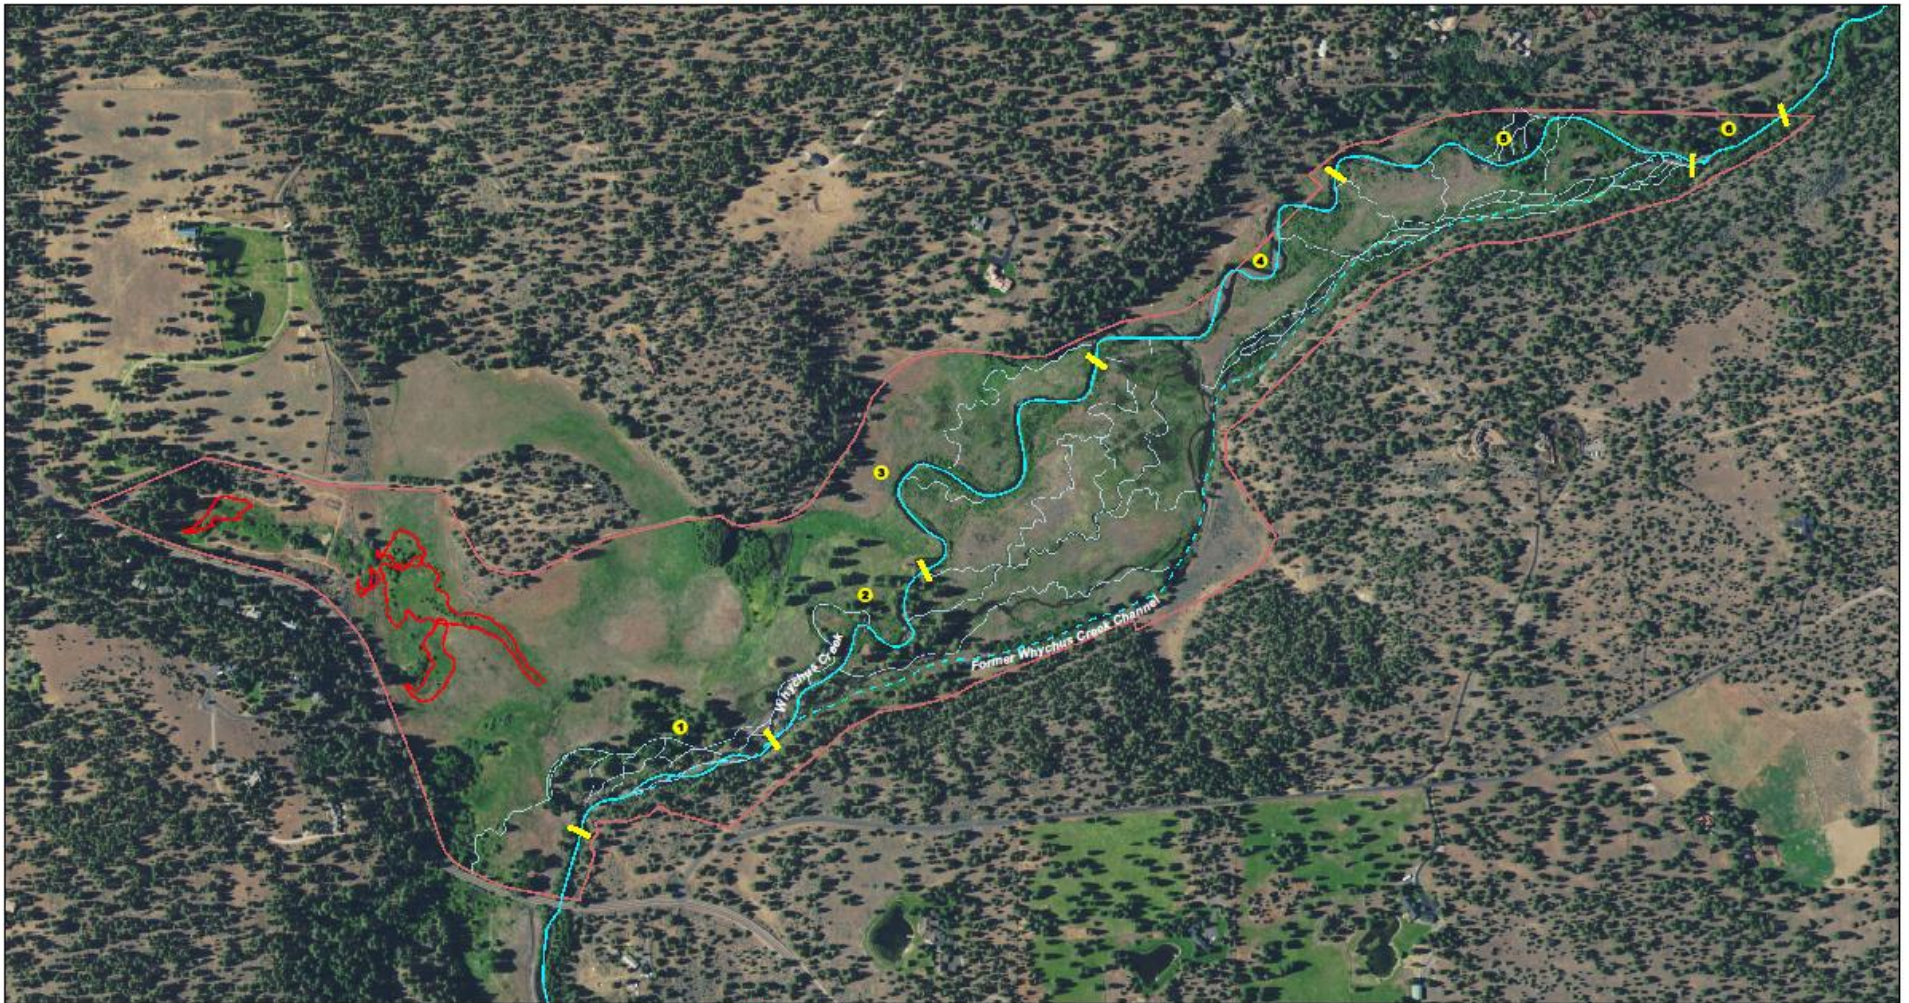
APPENDIX D. 2016 weed treatments at Camp Polk Meadow

Camp Polk Meadow: Canada Thistle treated in 2016

As in 2015, management actions in 2016 included hand-pulling and clipping of spotted knapweed, mullein, and bull thistle. The Canada thistle and common teasel populations treated in 2015 demonstrated improvements. One small, isolated population of Canada thistle to the west of the main populations exhibited very little re-emergence in 2016 and therefore was not re-treated. Canada thistle and teasel continued to flourish in areas of saturated soils and near water where DLT had not treated in 2015 due to restrictions specific to the herbicide used. Accordingly, in 2016 DLT treated dry areas with Opensight as in 2015, and treated populations growing in saturated soils with an aquatic version of 2,4-D (Appendix D).
