# Unmanned Aerial Vehicle Photographic Survey of Whychus Creek and Adjacent Riparian Areas

MARCH 2018

Earth Design Consultants, Inc.  
Corvallis, Oregon  
[www.earthdesign.com](http://www.earthdesign.com)

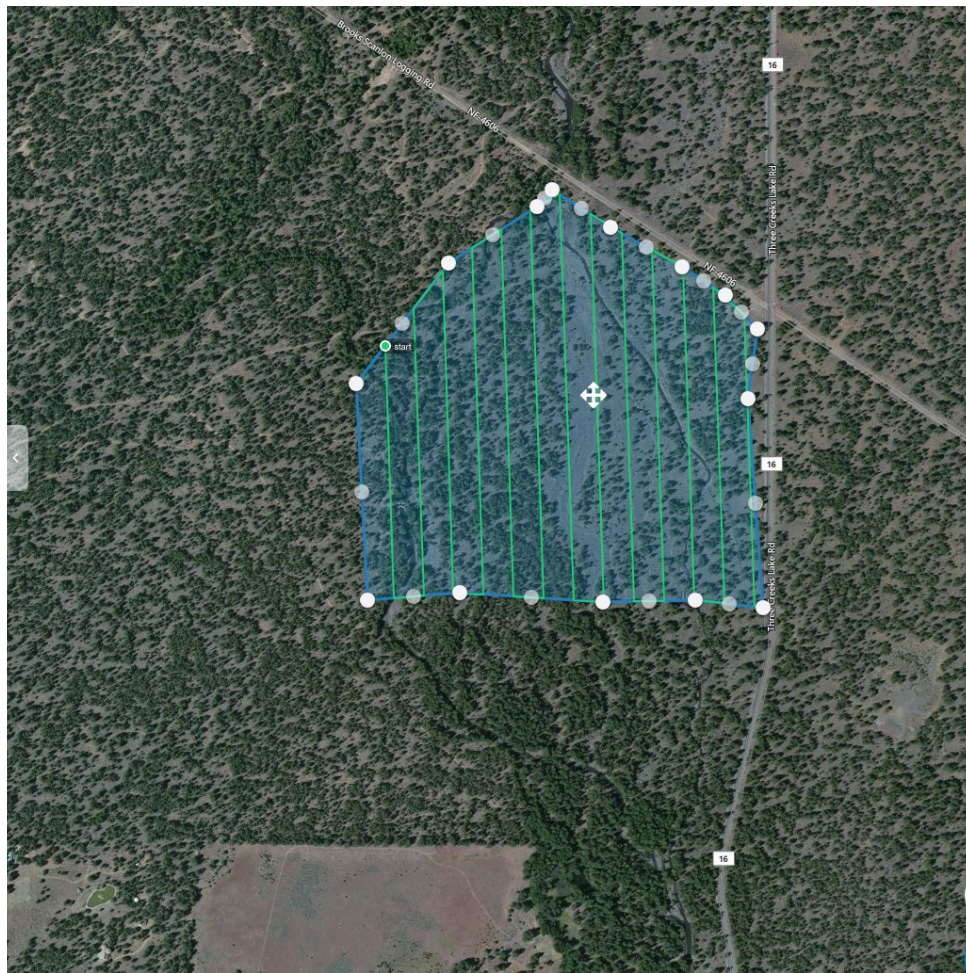
Figure 1a. Example of the arrangement of flight lines for a mission South of Sisters, OR. Green lines show the planned flight direction of the UAV.

bottom, historic floodplain topography that could be re-activated through stream restoration. Thirty flight “missions” were planned based on the initial shapefile in order to acquire complete coverage of the AOI (Figures 1a and 1b). GPS start points (UAV launch locations) and site access points were established in the office prior to deploying to the field. Images were planned to be acquired within +/- 4 hours of solar noon to minimize shadows in heavily forested and steep canyon areas. We planned to acquire images under Visual Flight Rule Requirement weather minimums with wind speeds < 10-12 mph. Lighting and camera exposure settings were also considered and adjusted to produce high quality images. We planned to launch UAVs from the valley floor and fly at an altitude of 350 feet above the ground to achieve comparable pixel sizes among images and missions, and to avoid high terrain along some stream reaches. Each mission consisted of a series of flight lines arranged to provide 70% sidelap and 75% frontlap. Whenever possible, at least three adjacent flight lines were planned for each mission to ensure complete coverage of the area of interest (Figure 1a). In addition to overlap of adjacent images, we also planned for mission areas to overlap (Figure 1b). Finally, care was taken to ensure that homes were not flown over without landowner permission.

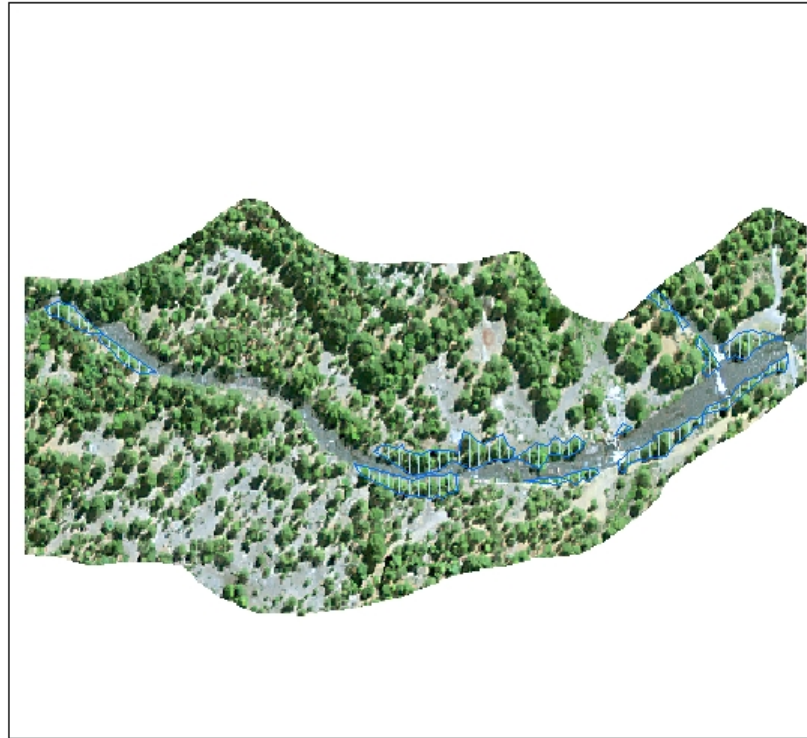
# TSID

TSID, Riparian, 2017

TSID, Riparian, 2009

1.13 Acres of Riparian Vegetation in 2009  
5.42 Acres of Riparian Vegetation in 2017

4.40 Acres Classified as Riparian in 2017 were Upland in 2009
