Upper Deschutes Watershed Council

Technical Report

2017-2019 Whychus Canyon Reach 4 Phase I Restoration Monitoring Report

May 2022

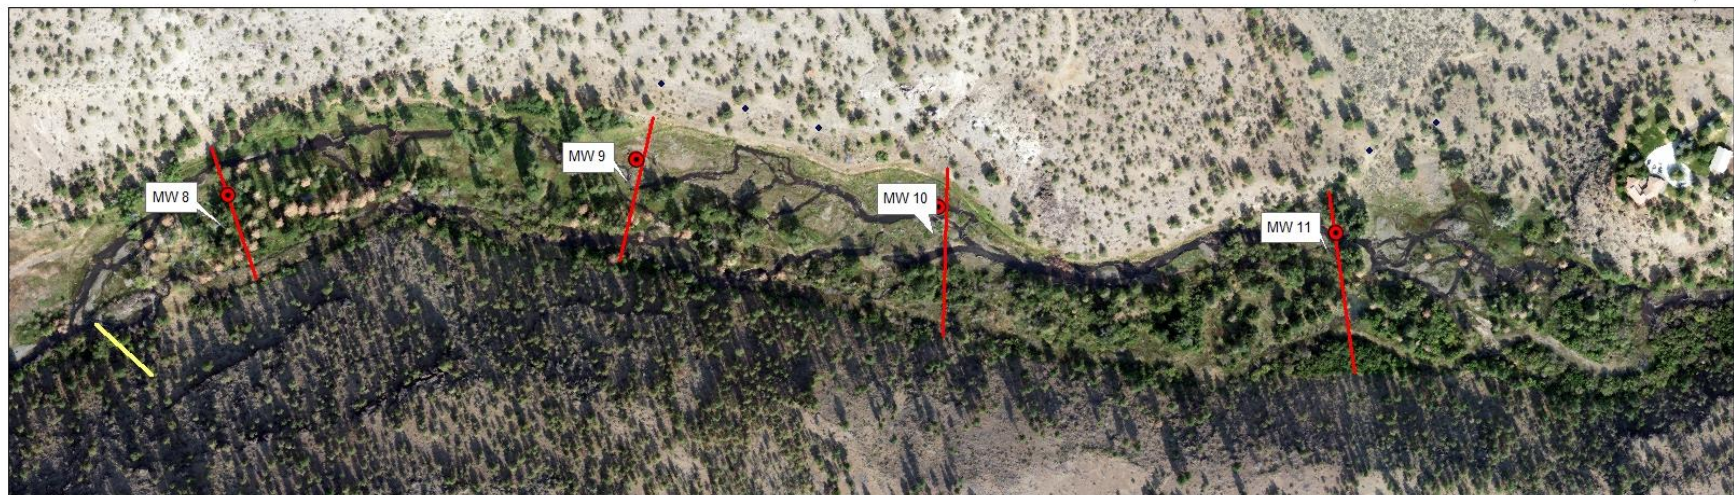
Whychus Canyon Reach 4 Groundwater Well and Cross-section Locations

Figure 2. Groundwater wells installed in Whychus Canyon Reaches 3 and 4, and Whychus Canyon Reach 4 cross-section locations associated with groundwater wells.

UDWC installed twelve groundwater wells in Whychus Canyon Reaches 3 and 4 in September, 2014 (Figure 2); four of the wells, including monitoring wells (MW) 8, 9, 10, and 11, were within Reach 4 and the Phase I project area. Following well installation, UDWC deployed a HOBO U20L water level datalogger (<https://www.onsetcomp.com/products/data-loggers/u20l-01/>; <https://www.onsetcomp.com/products/data-loggers/u20l-04/>) in each well and deployed a HOBO U20L datalogger in the MW 4 vault as a barometric transducer to record absolute pressure above sea level (ASL) for calibrating water level data. UDWC downloaded water level data in the field using the HOBO U-DTW-1 Waterproof Shuttle bi-annually from 2014 to 2016 and at additional intervals corresponding to monitoring and restoration implementation timelines. UDWC downloaded well data annually in fall 2017, 2018, and 2019 to capture both the lowest water levels and the point where groundwater began to increase each year, which we had observed from pre-restoration groundwater data to occur as late as October. In January 2015 we found the barometric transducer logger submerged in standing water in the MW 4 vault and moved it into the MW 11 vault. Prior to project implementation in August 2016 we moved the barometric transducer into the equipment shed in Whychus Canyon Reach 3 to prevent the logger from being submerged when groundwater was high enough to fill the well vaults.

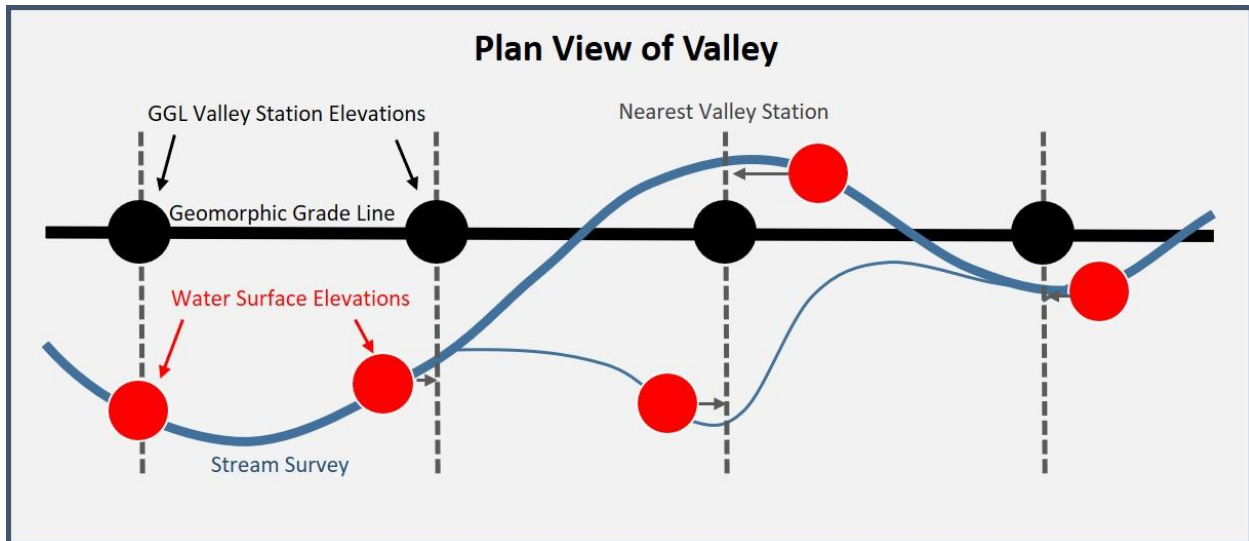
Figure 3. Graphical representation of process to a) associate each surveyed water surface elevation with the nearest Geomorphic Grade Line valley station, and b) plot each water surface elevation against the associated GGL valley station at the longitudinal location of the GGL valley station.

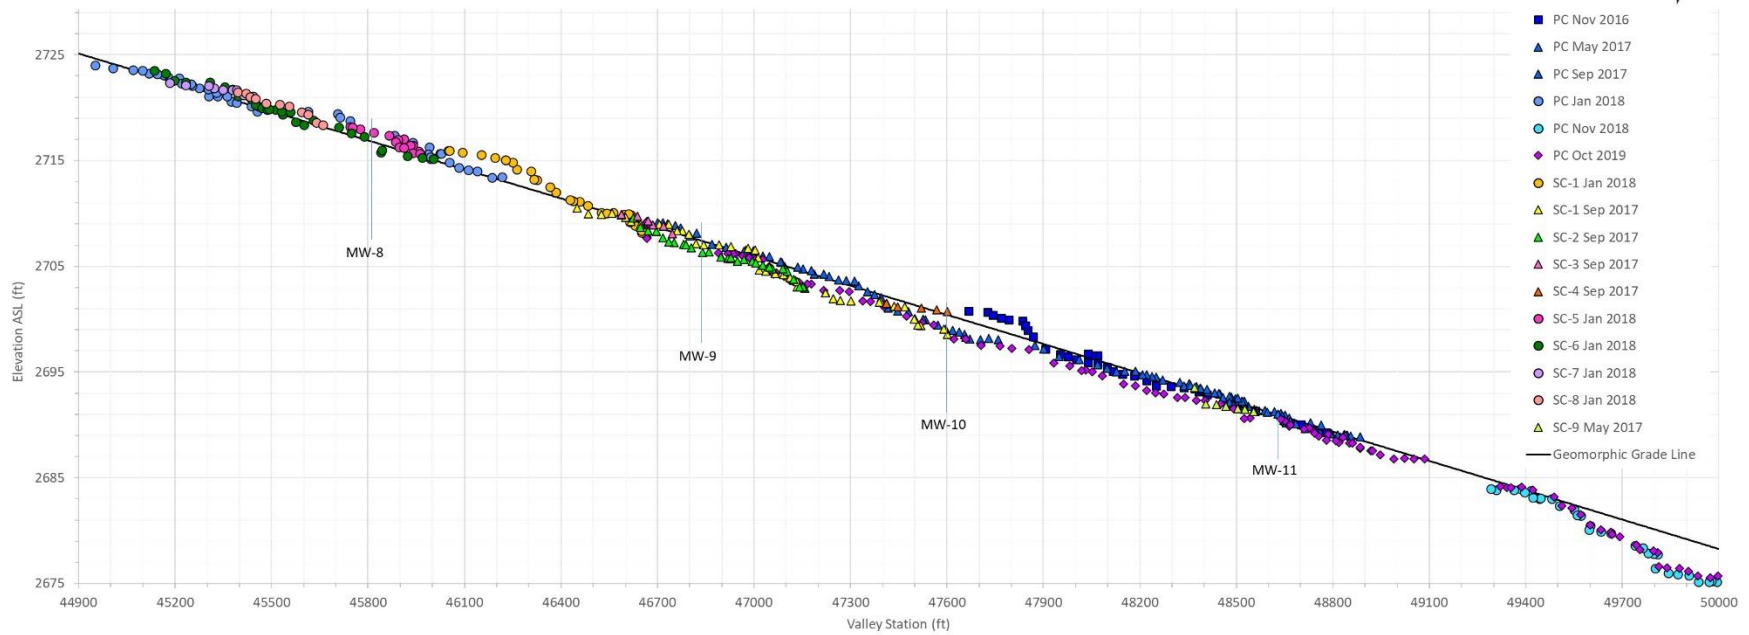
Figure 5. Top: The primary channel (PC) and side channels (SC) surveyed by date. Bottom: Channel elevation data collected during each survey event, plotted at corresponding valley station distances and elevations. Data point colors correspond to the colors of surveyed channels as drawn. Points above the Geomorphologic Grade Line design elevation indicate aggradation resulting from deposition; points below the GGL elevation indicate channel lowering resulting from erosion. October 2019 primary channel survey elevations are plotted on the chart but not drawn on the aerial image.

For 2017-2019 channel elevation monitoring we compared channel elevation data to design GGL valley station elevations rather than to as-built elevations measured following project implementation. For this reason channel elevation changes observed might not be accurate in that the as-built elevations could have been lower or higher than design elevations. For future monitoring, using surveyed as-built elevations as the basis for comparison of channel elevations will provide a more accurate assessment of how channel elevations change over time following restoration implementation.

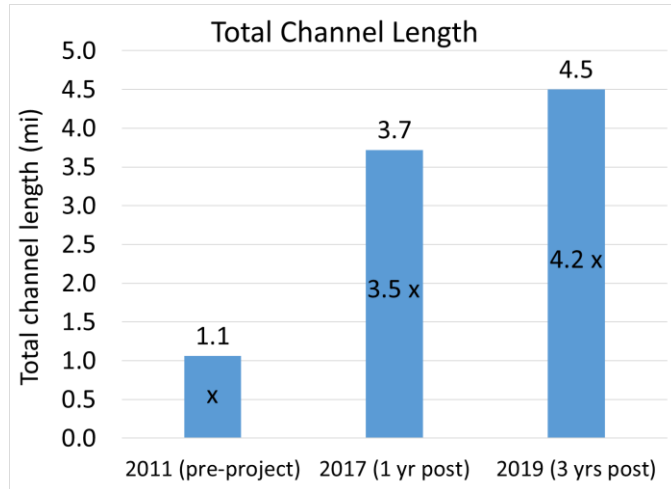
Figure 6. Total channel length in the Whychus Canyon Reach 4 project area was 3 and 4 times higher respectively in 2017 one year post-project and in 2019 three years post-project than in 2011 pre-project.

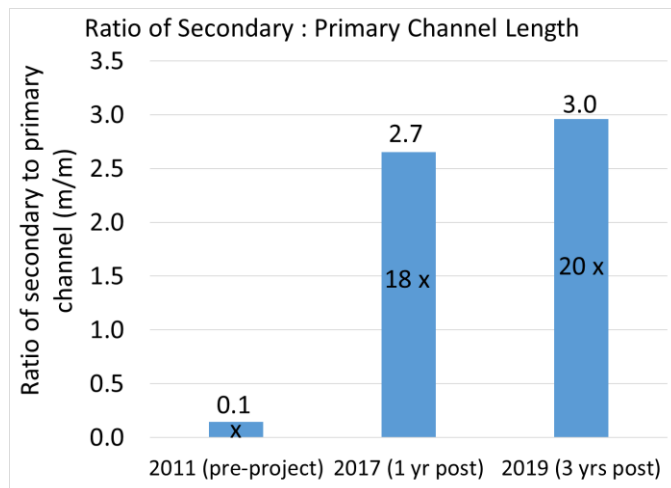
Figure 7. The ratio of secondary to primary channel length in the Whychus Canyon Reach 4 project area was 18 times higher in 2017 one year post-project and 20 times higher in 2019 three years post-project than in 2011 pre-project.

The ratio of secondary channel length to primary channel length increased from ten centimeters of secondary channel per meter of primary channel pre-restoration (0.1:1) to 2.7 meters of secondary channel for every meter of primary channel in 2019 (2.7:1), a 20-fold increase (Figure 7), exceeding the project objective of a secondary to primary channel length ratio greater than 1.5:1. The ratio of secondary channel length to primary channel length differed only slightly between 2017 (2.7:1) and 2019 (3:1).

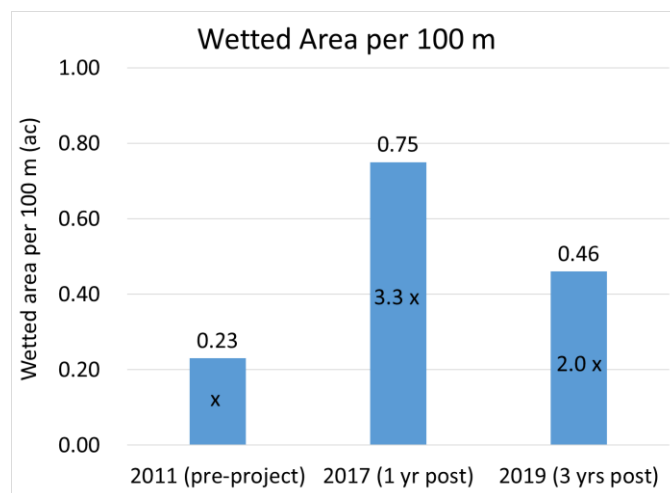
Figure 9. Wetted area per 100 m valley length in the Whychus Canyon Reach 4 project area increased from 0.23 ac per 100 m in 2011 pre-restoration to 0.75 ac per 100 m in 2017 one year post-project, decreasing in 2019 three years post-project to 0.46 ac per 100 m.

(Figure 9). Flow levels during 2017 and 2019 surveys may explain the decrease in wetted area from 2017 to 2019. Instantaneous flows during the 2017 survey fluctuated from 16 cfs to 138 cfs, with mean daily flow spanning 19 cfs to 65 cfs; the maximum instantaneous flow during the 2019 survey was 77 cfs, about half that during the 2017 survey, with mean daily flows between 16 cfs and 33 cfs. No target value was defined for this objective, however, the change in wetted area observed over two successive surveys one and three years post-restoration provides some insight into the proportion by which we can expect wetted area to increase as a result of projects implemented using a similar design.

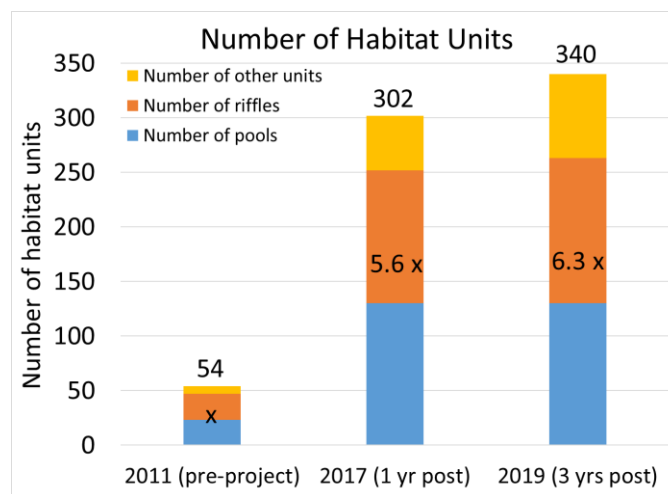
Figure 10. The number of habitat units in the Whychus Canyon Reach 4 project area was approximately 5.6 and 6.3 times higher respectively in 2017 one year post-project and in 2019 three years post-project than in 2011 pre-project.

The AIP stream habitat survey method classifies habitat units according to the slope of the water’s surface, flow characteristics, and substrate. Fifty-four habitat units numbered 311 to 364 were surveyed within the Whychus Canyon Reach 4 restoration project longitudinal extent in 2011, equivalent to 3.6 units per 100 m valley length. Units 310 and 365 spanned the boundary of the restoration project reach and adjacent reaches and were excluded from analysis. Three hundred and two (302) habitat units numbered 2 to 303 were surveyed in the Whychus Canyon Reach 4 extent in 2017, 20.3 units per 100 m valley length and 5.6 times the pre-project number (Figure 10). Three hundred and forty habitat units numbered 3 to 277 and 283 to 347 were surveyed in the Whychus Canyon Reach 4 extent in 2019, 22.9 units per 100 m valley length and 6.3 times the pre-project number; units 278 through 282 were outside the upstream project boundary. The increase in the number of units from 2017 to 2019 indicates continued channel evolution and increasing habitat complexity over three years post-project.

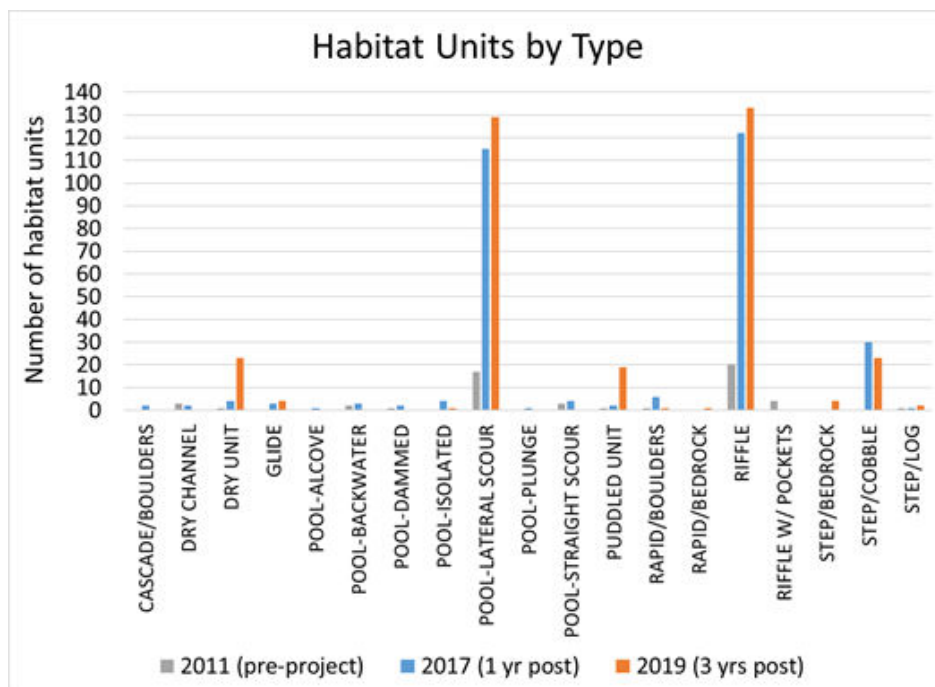
Figure 11. The number of different types of habitat units fluctuated between 11 and 16 from 2011 through 2019, with large increases in lateral scour pools, riffles, dry and puddled units, and step-cobble units accounting for the greatest change among years.

Increases in dry and puddled units in 2019 over both 2011 and 2017 numbers likely reflect both lower flows during 2019 surveys as compared to 2017 and possibly also channel consolidation and abandonment, although higher total channel length and ratio of secondary to primary channel lengths in 2019 than 2017 suggest avulsion and channel formation may have outpaced drying of channels. Dry and puddled units are included in calculating both total channel length and ratio of secondary to primary channel length.

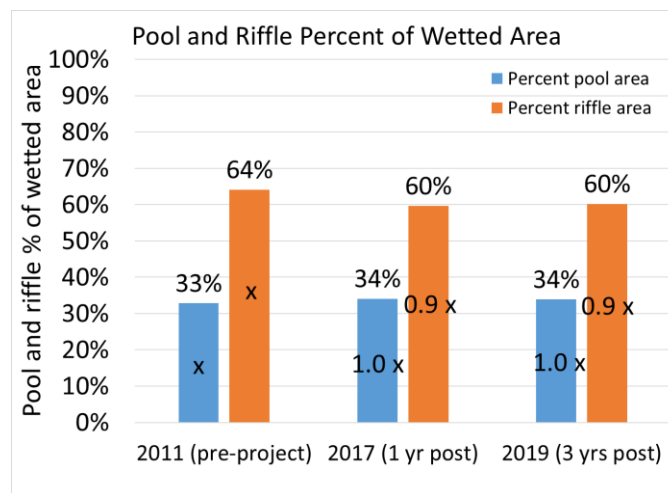
Figure 12. The percent of wetted area represented by pools and by riffles in the Whychus Canyon Reach 4 project area remained almost identical in 2017 one year post-project and in 2019 three years post-project compared to 2011 pre-project.

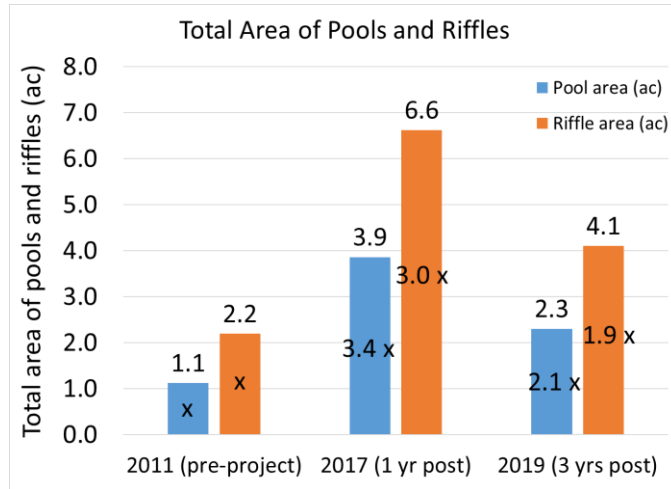
Figure 13. Total area represented by pools and by riffles in the Whychus Canyon Reach 4 project area increased to approximately 3x the 2011 area in 2017 one year post-project and decreased to approximately 2x the 2011 area in 2019 three years post-project for both unit types.

The total number of pools in the project reach increased from 23 in 2011 pre-restoration to 130 in both 2017 and 2019, one and three years post-restoration, respectively (Figure 10, Figure 11). Forty-three percent of all units were pools in both 2011 and 2017, decreasing slightly to 38% in 2019. Pool units represented 33% of 2011 wetted area and 34% of 2017 and 2019 wetted area (Figure 12). In 2011 1.1 ac of wetted area were pools, representing 0.08 ac of pool area per 100 m valley length; in 2017 3.4 ac of wetted area were pools, representing 0.26 ac of pool area per 100 m valley length, 3.4x the 2011 area, and in 2019 2.3 ac of wetted area were pools, representing 0.16 ac of pool area per 100 m valley length, 2.1x the 2011 pool area (Figure 13).

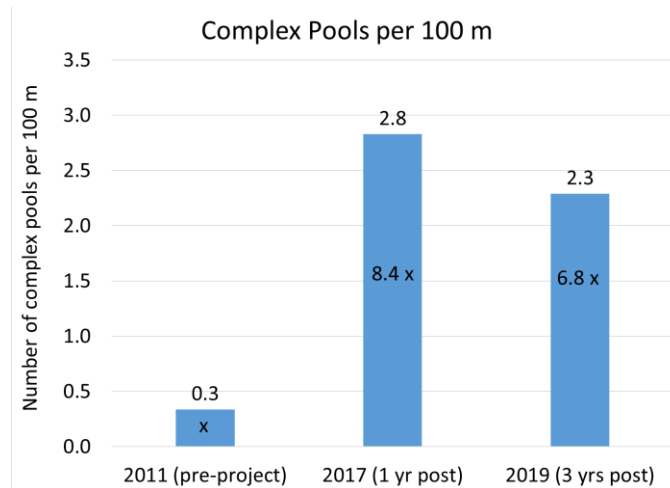
Figure 15. The number of complex pools in the Whychus Canyon Reach 4 project area was 8.4 and 6.8 times higher respectively in 2017 one year post-project and in 2019 three years post-project than in 2011 pre-project.

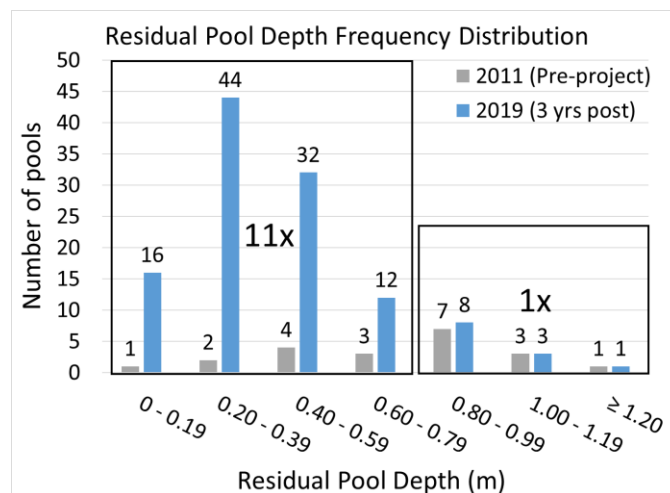
Figure 16. The number of pools with residual depths <0.80 m was 11 times higher respectively in 2019 three years post-project than in 2011 pre-project, while the number of pools with residual depths ≥ 0.8 m remained the same from 2011 to 2019.

The number of pools one meter deep or deeper per 100 m valley length decreased by half, from 1.3 in 2011 to 0.6 in 2017 and 0.7 in 2019. The number of pools with a residual depth <0.8 m increased 11-fold from 2011 to 2019, while the number of pools with a residual depth ≥ 0.8 m remained the same between 2011 and 2019 (Figure 16). Average residual pool depth in the project reach decreased by about half, from 0.72 m in 2011 to 0.38 m in 2017 and 0.43 m in 2019.

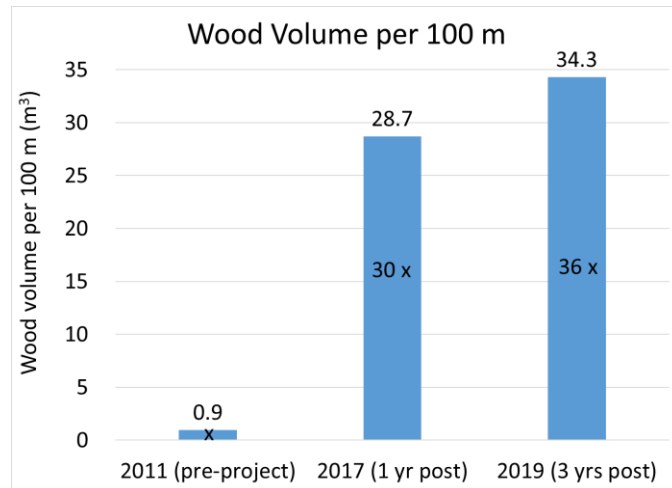
Figure 18. Wood volume per 100 m valley length was 30 and 36 times higher respectively in 2017 one year post-project and in 2019 three years post-project than in 2011 pre-project.

Wood volume per 100 m valley length increased from 0.9 m³ in 2011 to 28.7 m³ in 2017, a 30-fold increase, and to 34.3 m³ in 2019, a 36-fold increase over the 2011 volume (Figure 18).

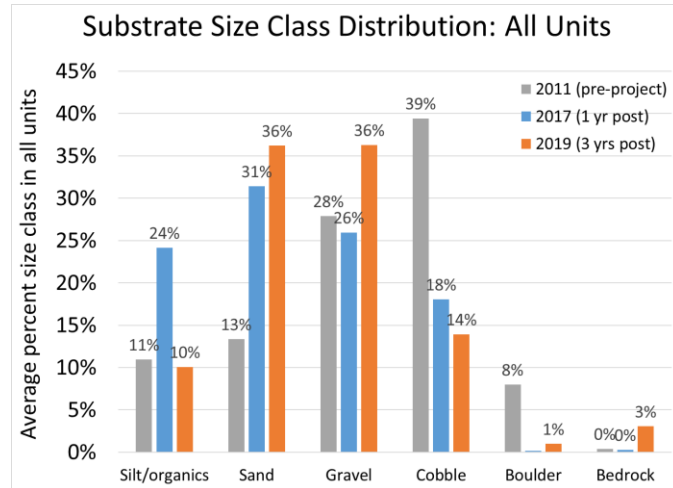
Figure 19. Average percentage of six substrate size classes in all habitat units in 2011 pre-restoration, 2017 one year post-restoration, and 2019 three years post-restoration.

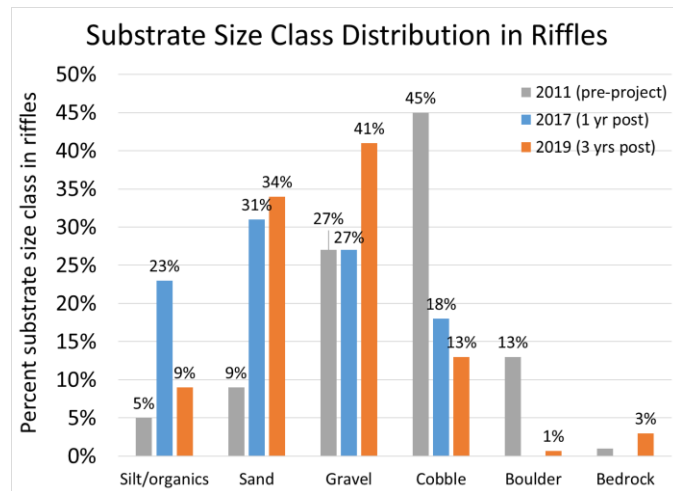
Figure 20. Average percentage of six substrate size classes in riffle habitat units in 2011 pre-restoration, 2017 one year post-restoration, and 2019 three years post-restoration.

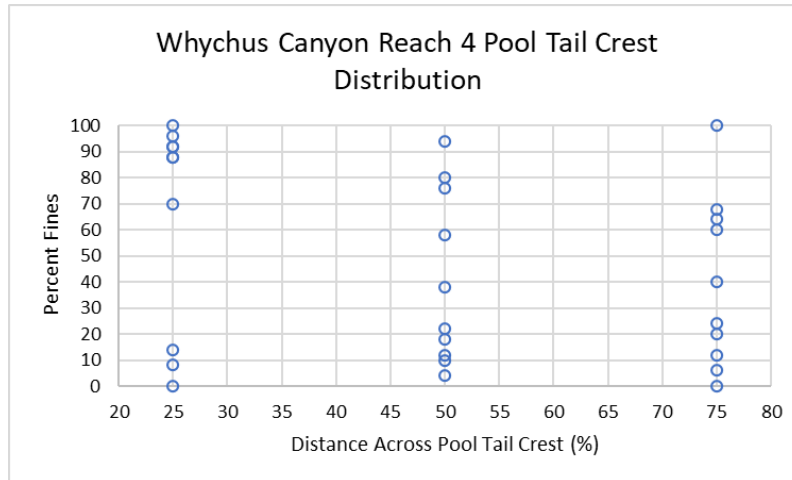
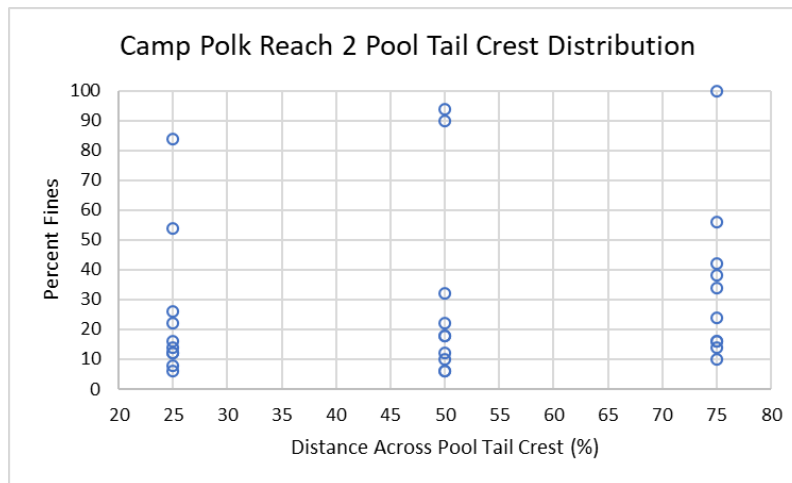
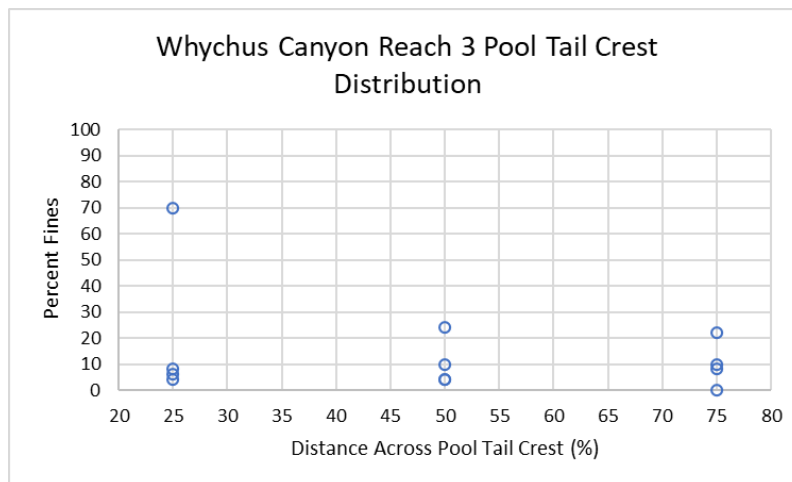
Figure 21. Percent fines measurements at 25%, 50% and 75% distances across tail crests of ten pools each in: a) Whychus Canyon Reach 4 and b) Camp Polk (restored in 2016 and 2012 respectively); and c) four pools in Whychus Canyon Reach 3 (unrestored).

We plotted the raw data for each of the three sites to visually compare the number of quadrats where fine sediment cover was below or above the 30% threshold identified in HabRate (Burke et al. 2010) as differentiating fair from poor spawning conditions, and calculated median fine sediment values for the three sites.

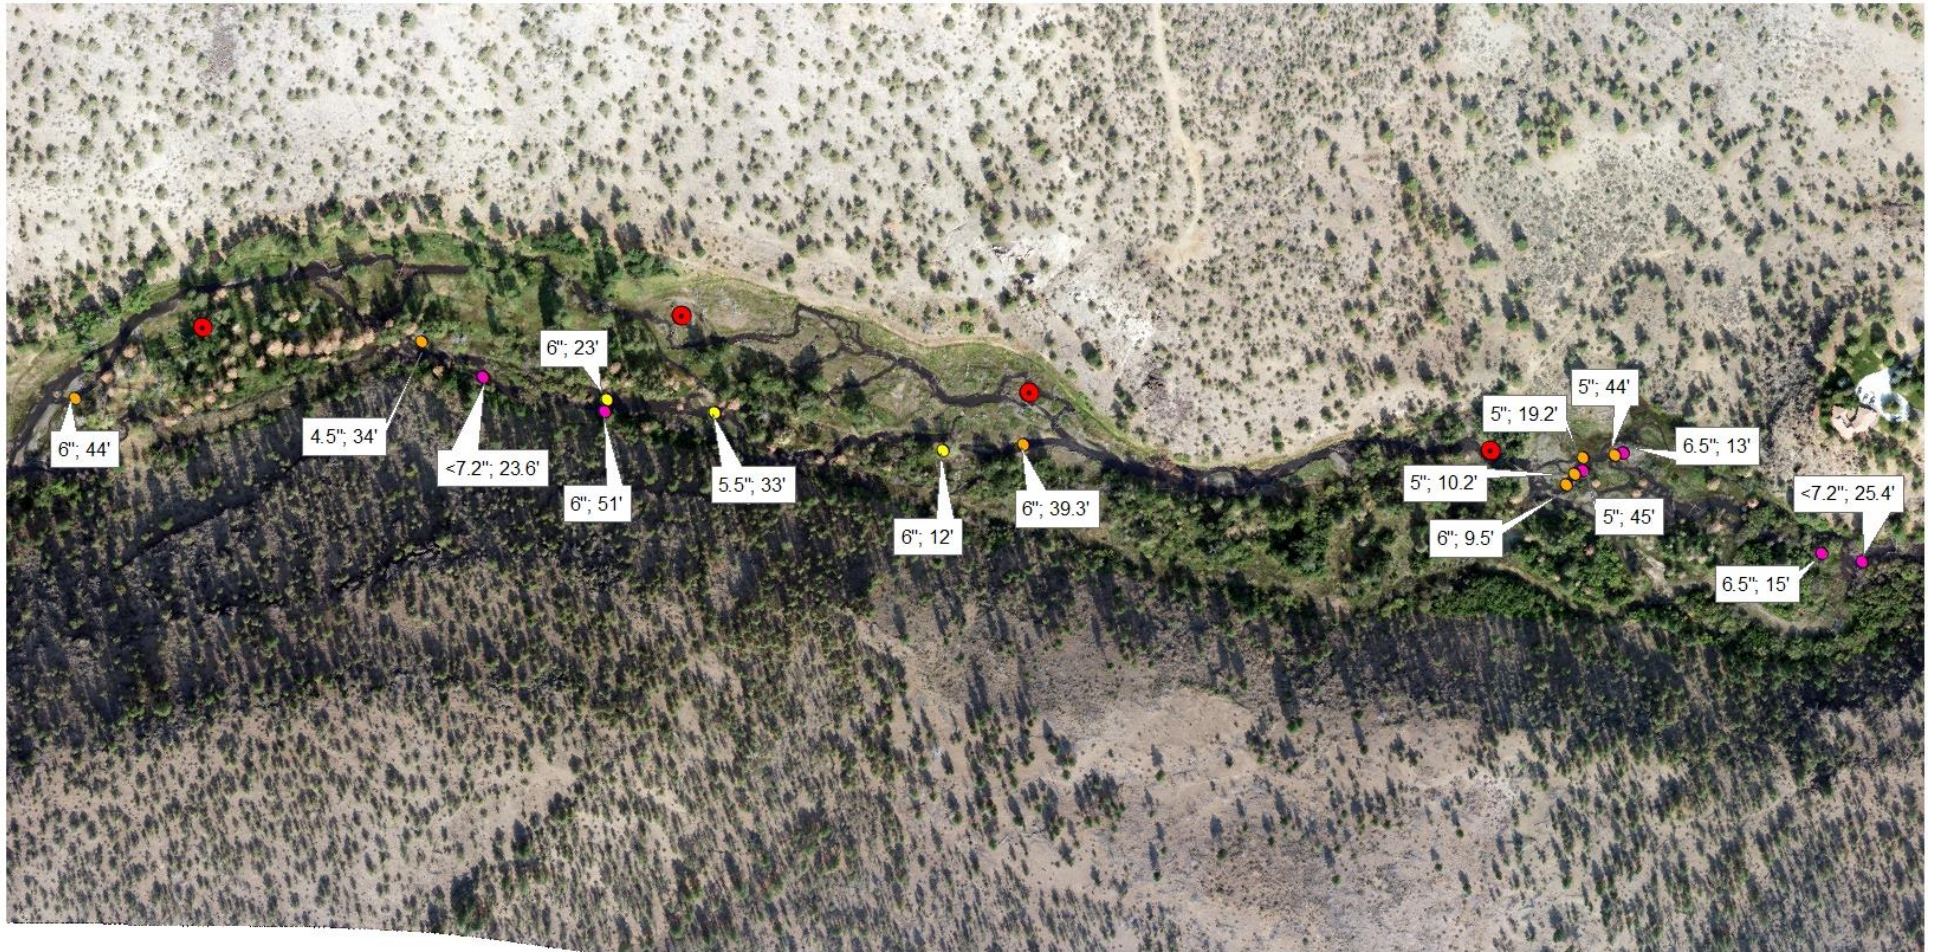
Whychus Canyon Reach 4 Fish Passage Surveys 2017-2019

- Groundwater wells
- 2017 survey
- 2018 survey
- 2019 survey

UDWC and USFWS staff walked the primary channel beginning at the downstream end of the project reach. We used D-net handles marked at 7.2" to allow us to rapidly assess depth. Where the channel was shallower than 7.2" over a length greater than the channel width, we assessed nearby connected channels to evaluate if they met the 7.2" criteria. If no continuous flow path meeting 7.2" depth was found, the minimum depth and length of primary channel not meeting the criteria were measured and recorded and the center of that length marked on an aerial image using the Avenza app. UDWC and USFWS staff applied the same protocol along approximately a quarter-mile reach downstream and upstream of the restoration reach to assess whether depths in unrestored reaches met the depth criteria.

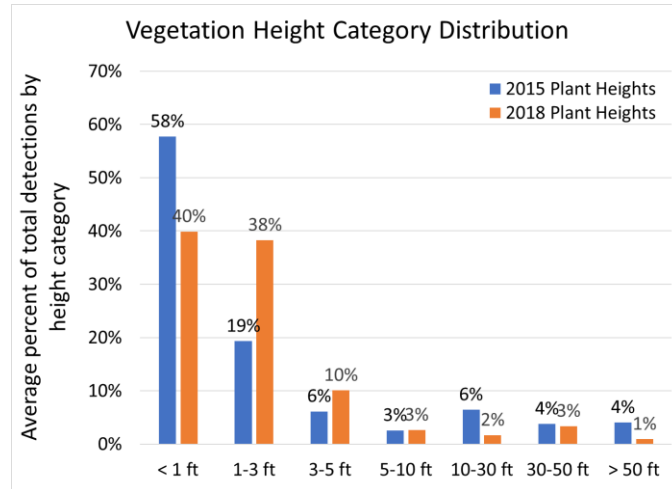
Figure 25. Plant heights shifted to fewer short and more taller plants from 2015 to 2018, consistent with planting, seeding, and natural recruitment of native grasses, sedges, rushes, bulrushes, shrubs and trees during restoration that exhibit greater structural diversity than the pre-restoration community.

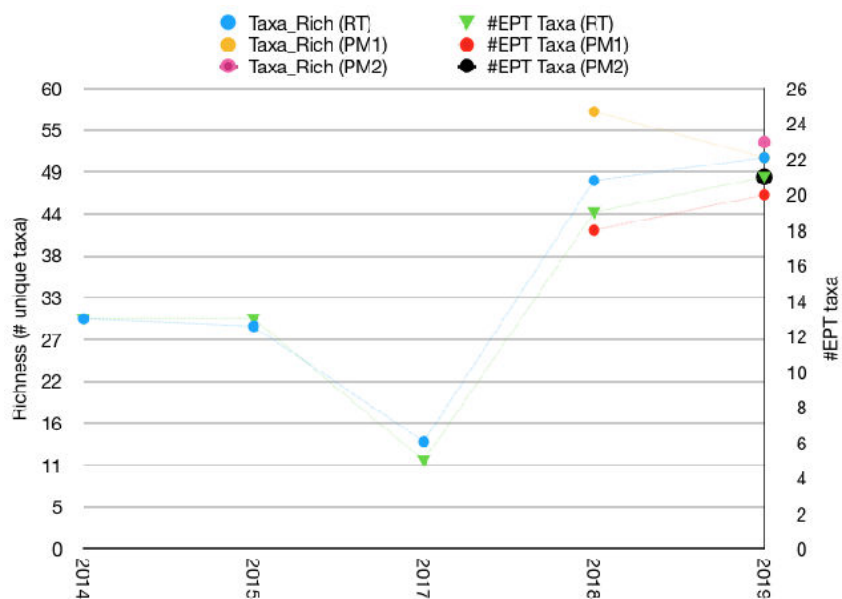
Figure 27. Sample richness and EPT diversity at WC1100 in all sampling years. Only samples taken in the primary channel are shown. The PM1 and RT samples were taken in the same reach at the same time in 2018-2019. For this metric in the ORDEQ IBI, > 35 total taxa receives the highest scaled score.

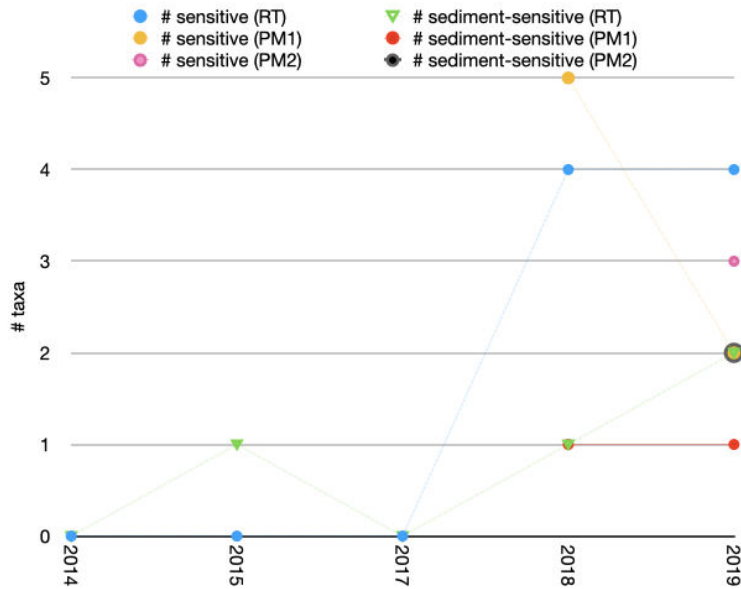
Figure 29. Numbers of sensitive and sediment-sensitive taxa at WC1100 in all sampling years. Only samples taken in the primary channel are shown. The PM1 and RT samples were taken in the same reach at the same time in 2018-2019. In the ORDEQ IBI, the highest scaled score correlates with >4 sensitive and >2 sediment-sensitive taxa.

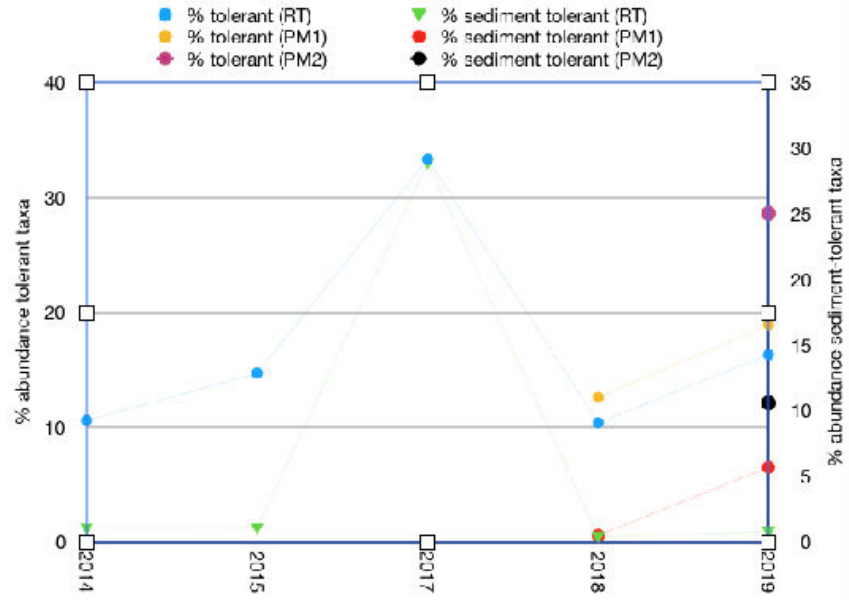
Figure 30. Numbers of tolerant and sediment-tolerant taxa at WC1100 in all sampling years. Only samples taken in the primary channel are shown. The PM1 and RT samples were taken in the same reach at the same time in 2018-2019. In the ORDEQ IBI, the highest scaled score correlates with <15% tolerant and <10% sediment-tolerant taxa

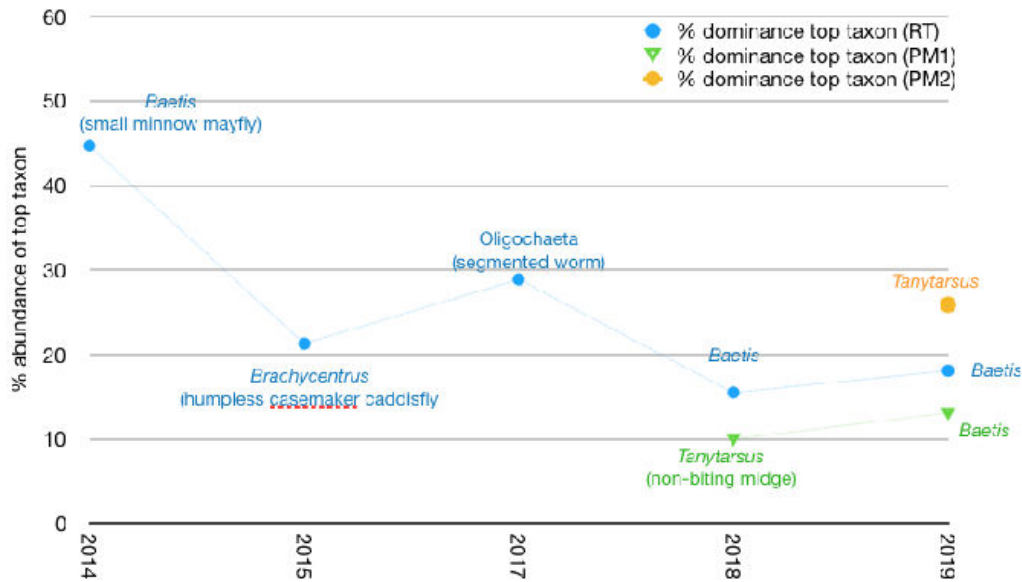
Figure 31. Relative abundance of the numerically dominant taxon at WC1100 in all sampling years. Only samples taken in the primary channel are shown. The PM1 and RT samples were taken in sampling reach WC1100-2 at the same time in 2018-2019, and the PM2 sample was collected from sampling reach WC1100-1 in the “lower delta” in 2019. In the ORDEQ IBI, the highest scaled score correlates with <20% abundance of the top taxon.

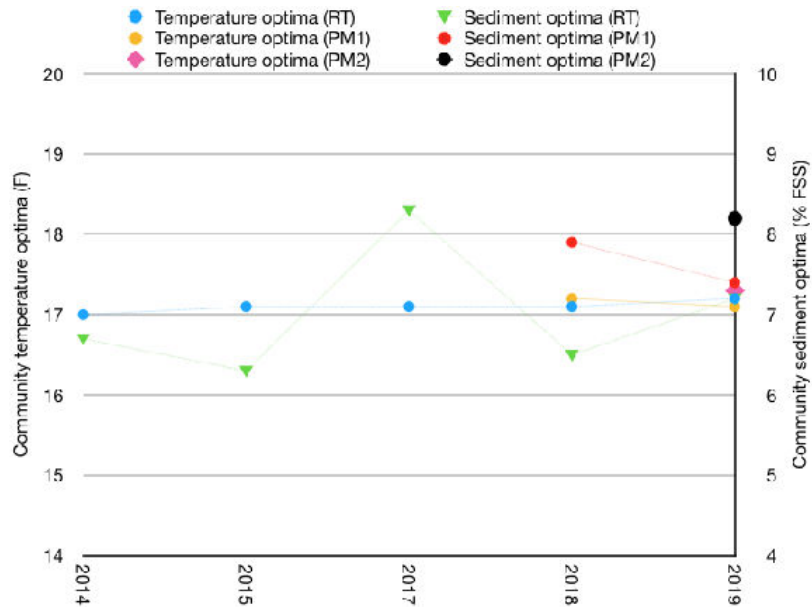
Figure 32. Temperature and fine sediment optima of the community at WC1100 in all sampling years. Only samples taken in the primary channel are shown. The PM1 and RT samples were taken in the same reach at the same time in 2018-2019.

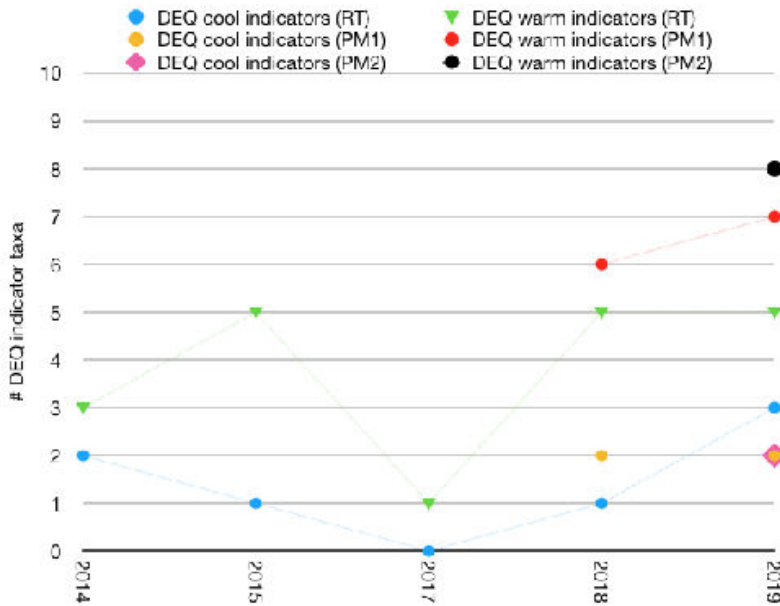
Figure 33. Number of ORDEQ cool and warm temperature indicator taxa at WC1100 in all sampling years. Only samples taken in the primary channel are shown. The PM1 and RT samples were taken in the same reach at the same time in 2018-2019. Note that these taxa do not account for the temperature associations of all taxa in a sample.

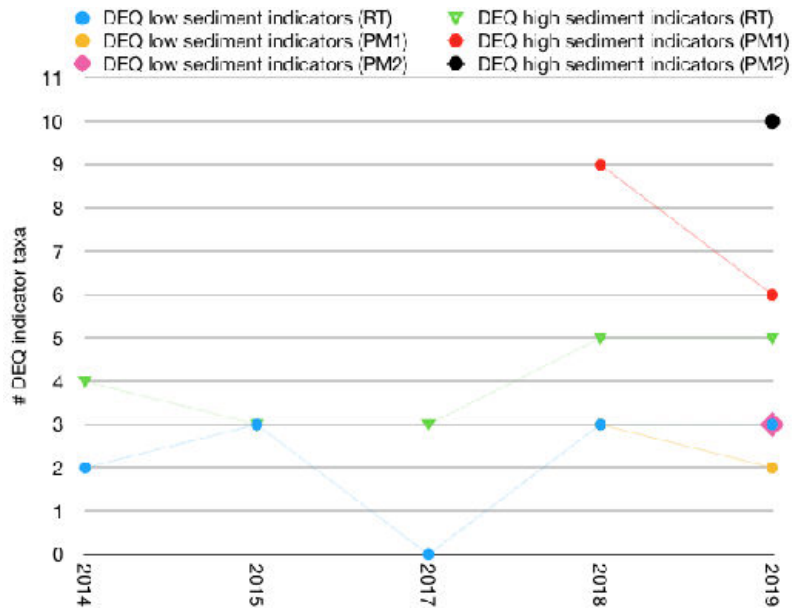
Figure 34. Number of ORDEQ low and high sediment indicator taxa at WC11100 in all sampling years. Only samples taken in the primary channel are shown. The PM1 and RT samples were taken in the same reach at the same time in 2018-2019. Note that these taxa do not account for the sediment associations of all taxa in a sample.

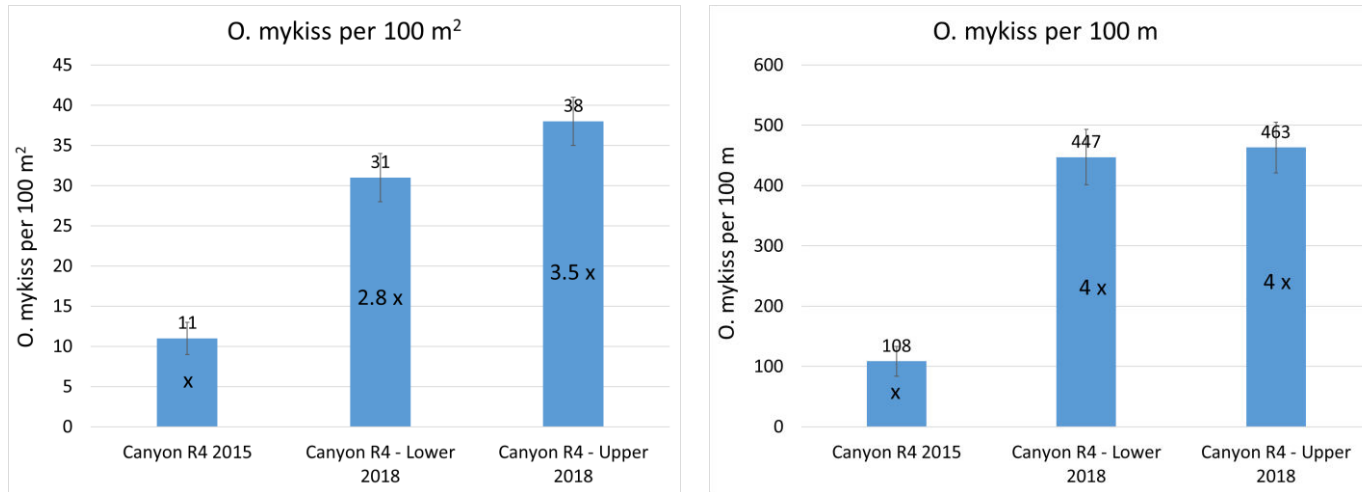
Figure 39. Resident and juvenile O. mykiss per 100 m² and per 100 m in Whychus Canyon Reach 4 in 2015 pre-restoration and in Lower and Upper survey reaches in Whychus Canyon Reach 4 in 2018, two years post-restoration.

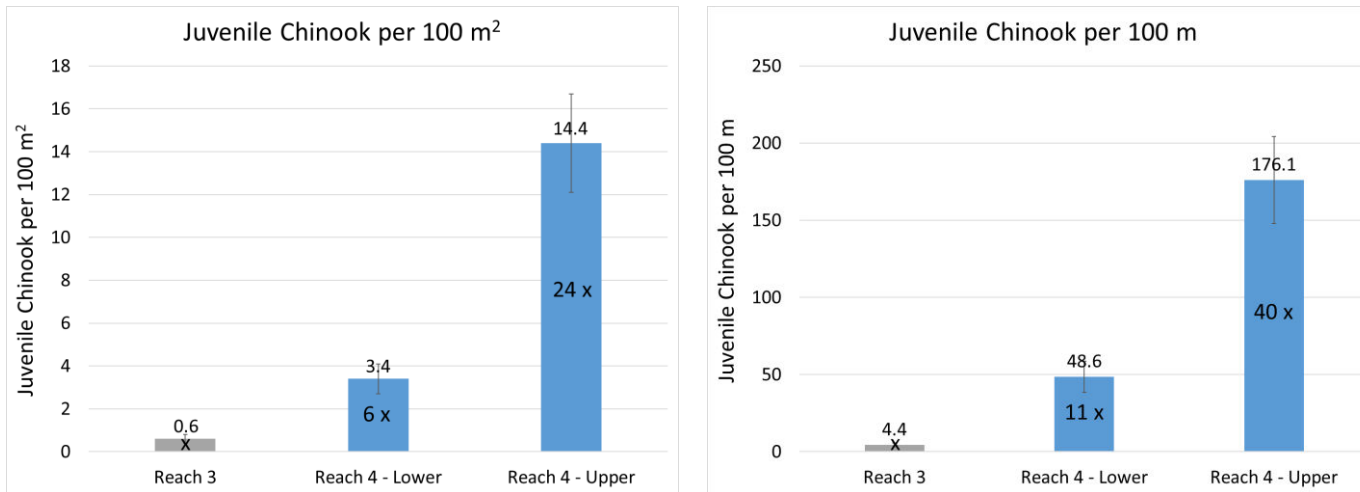
Figure 40. Juvenile spring Chinook salmon per 100 m² and per 100 m in the unrestored control Whychus Canyon Reach 3 and in Lower and Upper survey reaches in Whychus Canyon Reach 4 in 2018, two years post-restoration.
