Upper Deschutes Watershed Council
Technical Report

2020 Whychus Creek Stage 0 Restoration Effectiveness Monitoring

Upper Deschutes Watershed Council

October 30, 2023

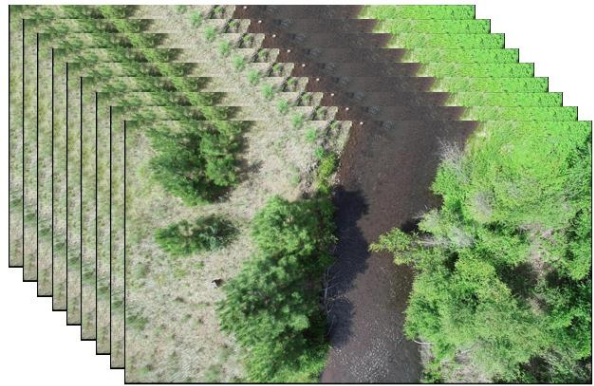
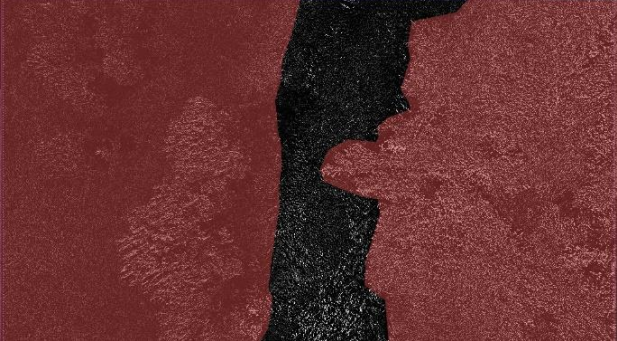
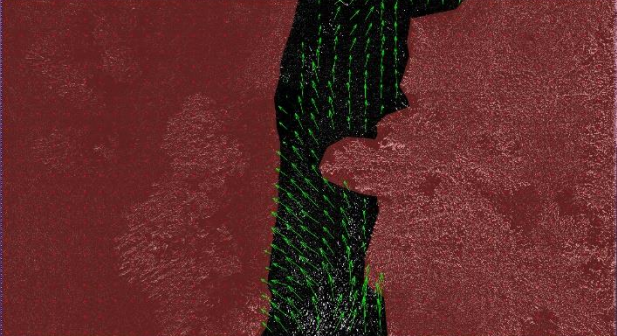
Figure 3. Processing steps used in the PIV analysis.

<p>Step 1: Extract image frames from video and stabilize images to remove aircraft motion.</p>

<p>Step 2: Create mask of non-channel features and increase image contrast to enhance water surface features. Red areas of the image were excluded from the analysis.</p>

<p>Step 3: Measure tracer displacement between image frames using automated particle image velocimetry. The green vectors are the PIV-derived magnitude and direction of the flow.</p>

The USGS tested the PIV workflow (provided in Figure 3 in Methods) in variable channel environments including pools, riffles, glides and a more complex post-restoration, multi-channel configuration (Figure 10). Debris or bubbles on the water surface were present in some of the plots and provided natural tracers of the water surface velocity. Texture and waves on the water surface provided the dominant source of velocity information in the videos.

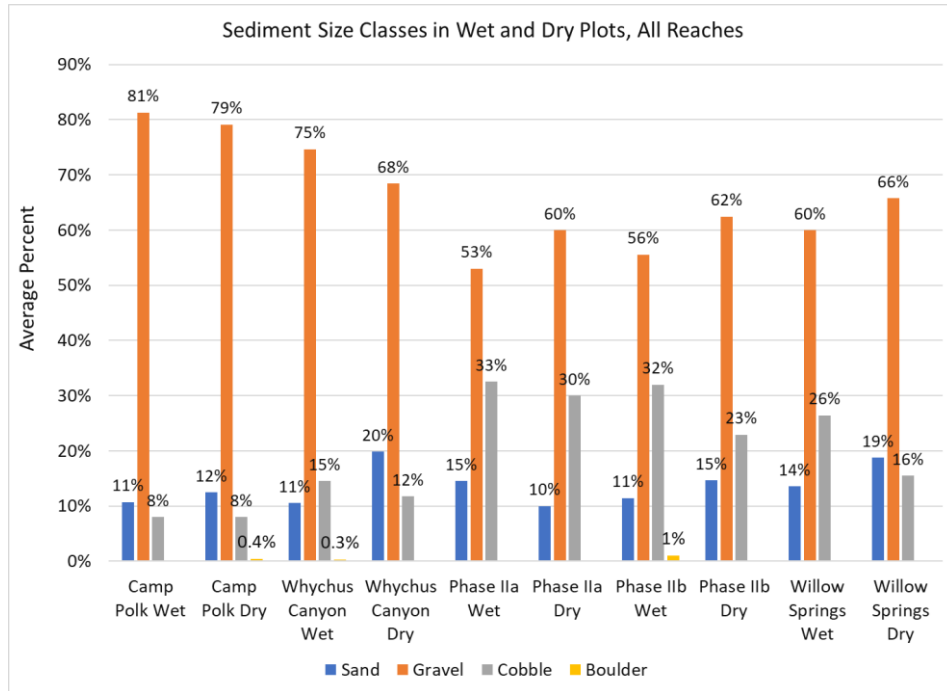
Figure 15. Average percentages of sand, gravel, cobble, and boulder by wet and dry plots in each reach.

Wet and dry plots had similar percentages of gravel whether in restored or in unrestored reaches, with differences between wet and dry plots ranging from 2-7% (Figure 15). Percentages of cobble were also similar in wet and dry plots in restored reaches and in Whychus Canyon Phase 2a, which had not yet been restored as of 2020. Percentages of cobble in both Phase 2b and Willow Springs were on average 10% higher in wet plots than in dry plots, possibly an artifact of mobilization and deposition of the smaller classes, but not cobble, outside of active channels, i.e. where dry plots were located, during flood flows in confined, unrestored reaches.

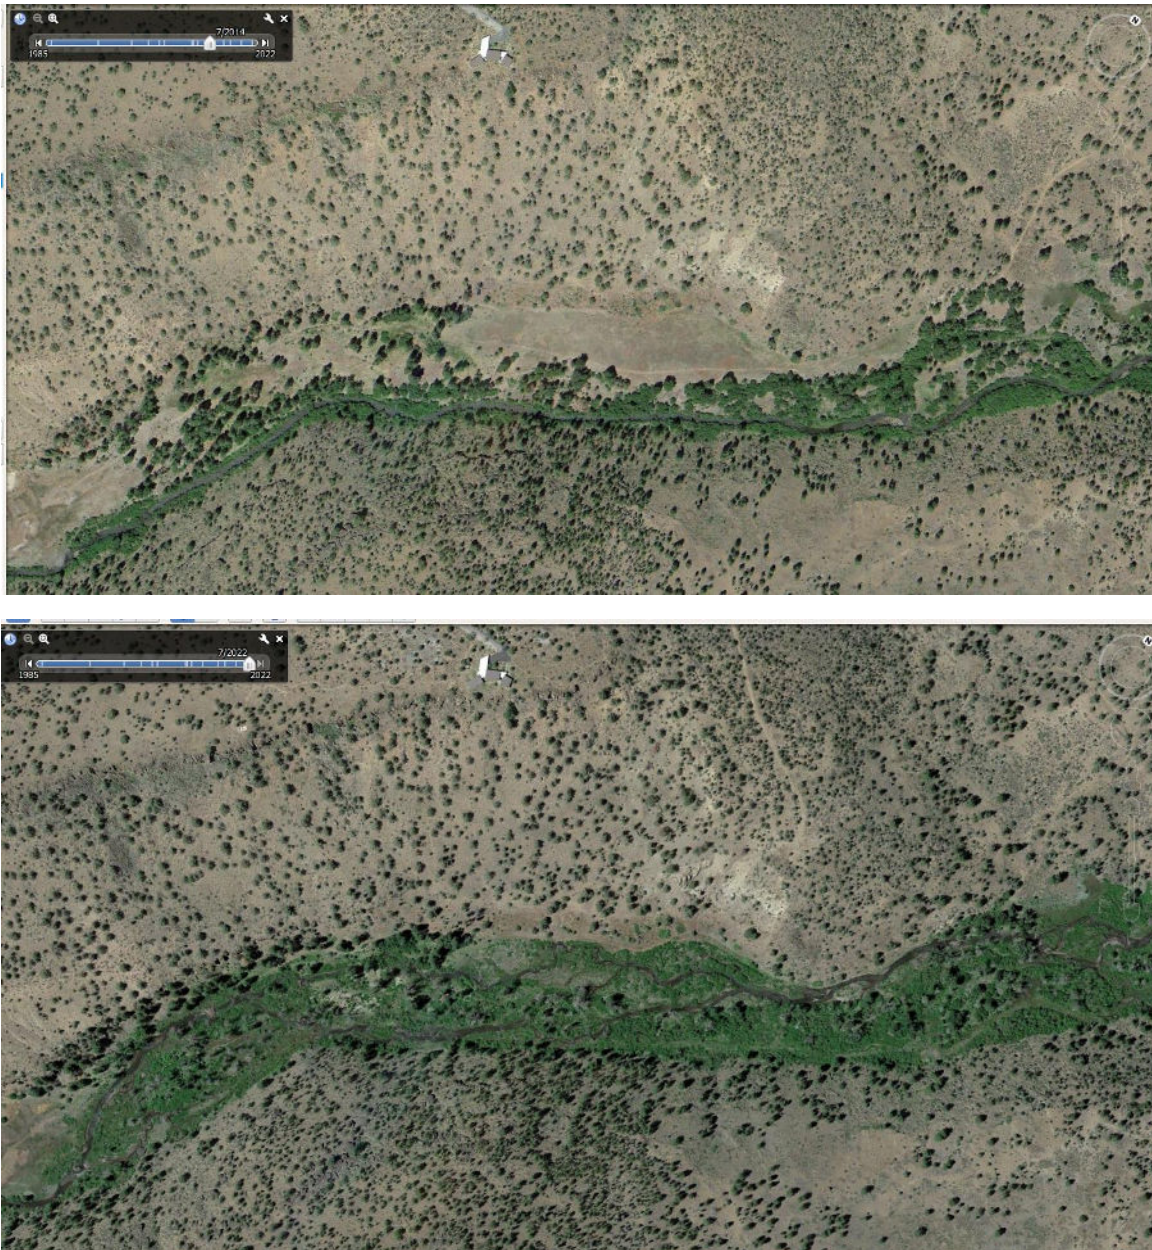
Figure 22. Visually observable differences in vegetation greenness and density in Whychus Canyon Phase 1 pre-restoration in July 2014 (top) and post-restoration in July 2022 (bottom) suggest NDVI or NDWI might be good candidate methods for classifying riparian vegetation in restoration reaches.
