Remote sensing methods for monitoring Stage 0 metrics on Whychus Creek using high-resolution imagery

McCurdy, W; Schwert, B; Schaaf, A; Davenport, J.; Kutz, K.; Fisk, H., Mork, L.; Press, C.; 2021. Remote sensing methods for monitoring Stage 0 metrics on Whychus Creek using high-resolution imagery.

GTAC-10196-RPT1. Salt Lake City, UT: U.S. Department of Agriculture, Forest Service, Geospatial Technology and Applications Center. 41 p.

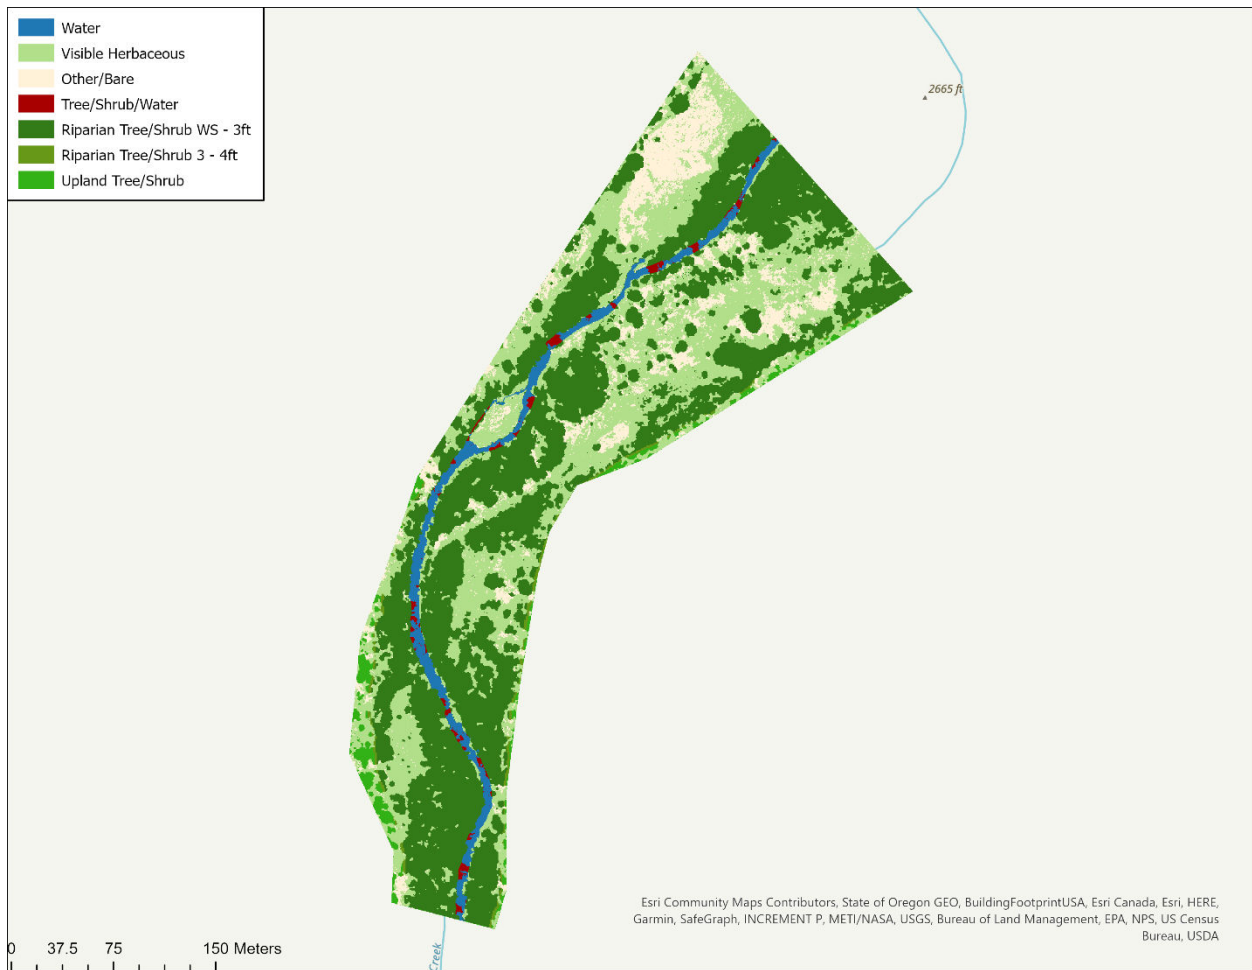
Figure 10: Land cover classification for Whychus Canyon Phase 2a.

We created land cover classification rasters for each of our reaches. These classifications each had eight classes, including water, and were represented at a final resolution of ~5.3 cm. Our overall classification accuracy was 36.67%, and accuracies varied widely between reaches and classes, and even between user’s accuracy and producer’s accuracy for the same land cover class. For example, in Phase IIa herbaceous cover had a user’s accuracy of 12.5%, indicating that only 12.5% of vegetation identified as herbaceous cover was actually herbaceous cover according to vegetation rapid assessment data, while upland tree/shrub had a user’s accuracy of 100%, indicating all vegetation identified as upland tree/shrub was also classified as upland tree/shrub according to vegetation rapid assessment data (in contrast, a producers accuracy of 100% would have meant that 100% of reference sites were correctly classified). Accuracy for riparian tree/shrub tended to be higher than accuracy for herbaceous and other, but again varied widely between 100% and 0% within a reach (see tables 3-13).

Land cover type	Area (acres)	Percent Area
Water	0.87	4.01%
Upland Tree/Shrub	1.03	4.74%
Visible Herbaceous	7.55	34.76%
Other/Bare	2.24	10.31%
Riparian Tree/Shrub/Water	0.16	0.74%
Riparian Tree/Shrub (WS – 3 ft)	9.76	44.94%
Riparian Tree/Shrub (3 – 4 ft)	0.11	0.51%
Total Inundated	1.02	4.70%
Total	21.72	100.00%

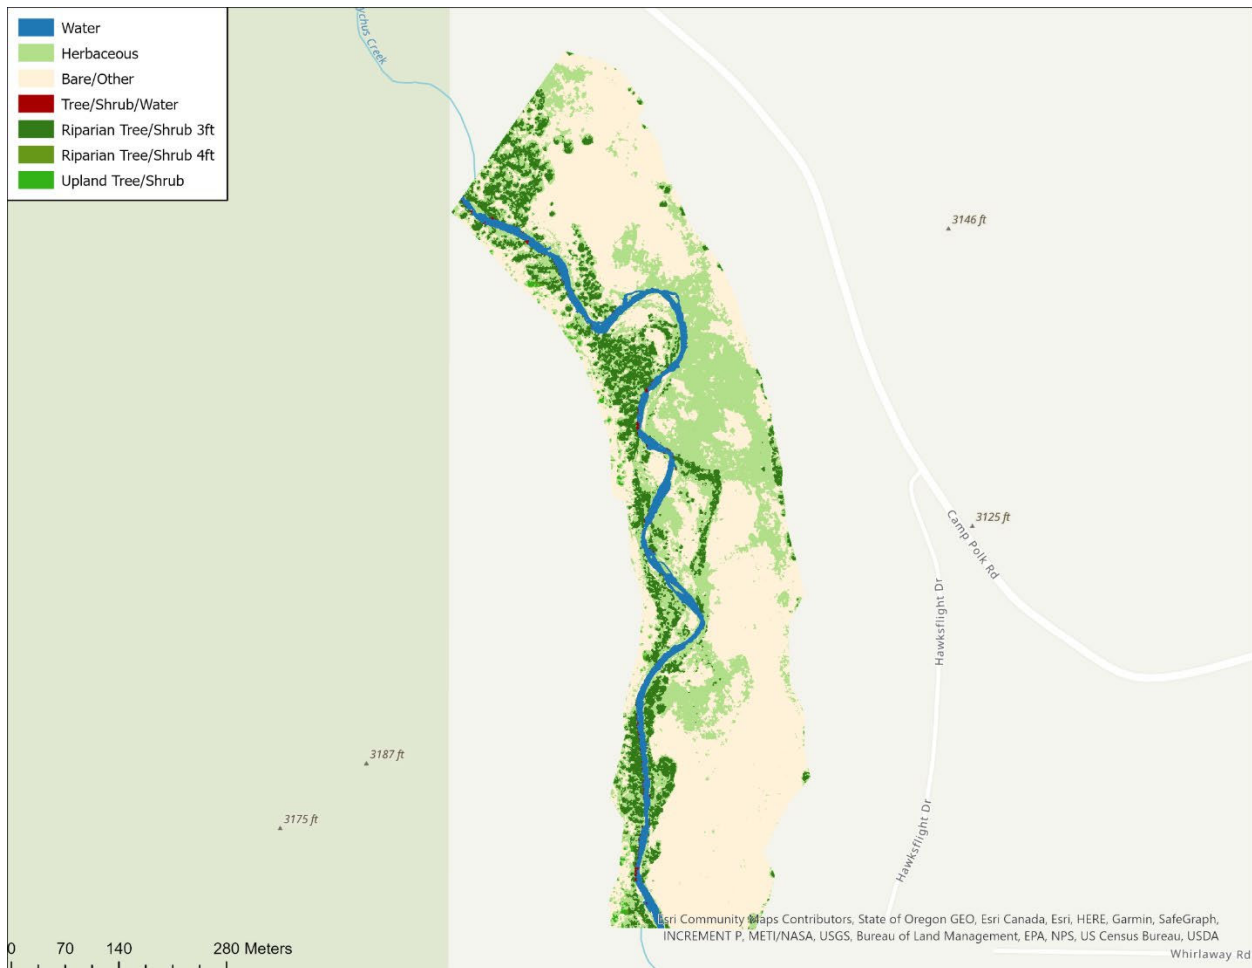
Figure 13: Land cover classification for Willow Springs.

Land cover type	Area (acres)	Percent Area
Water	2.91	4.80%
Upland Tree/Shrub	0.42	0.69%
Visible Herbaceous	16.89	27.84%
Other/Bare	34.02	56.07%
Riparian Tree/Shrub/Water	0.08	0.13%
Riparian Tree/Shrub (WS – 3 ft)	6.2	10.22%
Riparian Tree/Shrub (3 – 4 ft)	0.15	0.25%
Total Inundated	2.99	4.90%
Total	60.67	100.00%

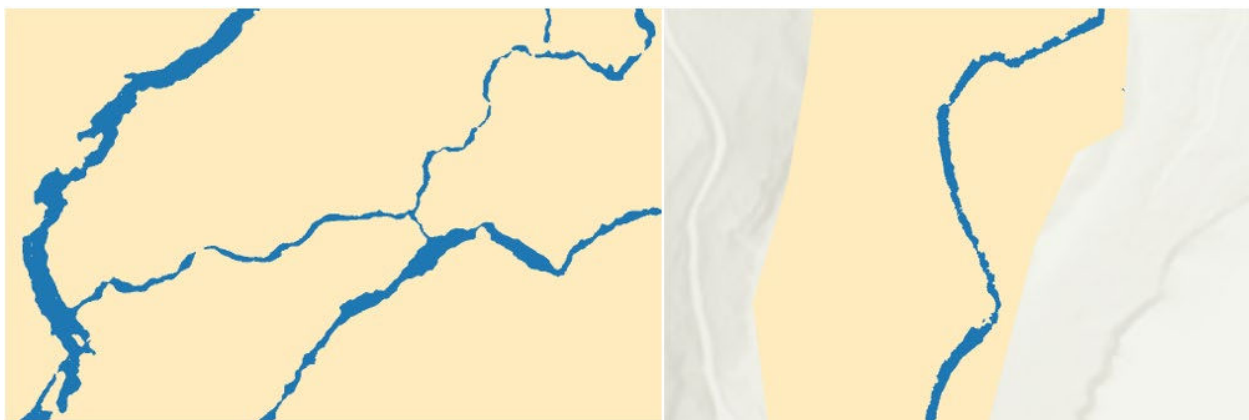
Stream area during baseflow did not change much between post-restoration and pre-restoration reaches. However, the amount of stream branching between pre-restoration and post-restoration reaches was noticeable and significant. Post-restoration reaches had much more branching than pre-restoration reaches, which is consistent with the goals of a Stage 0 restoration (Powers et al. 2018; Cluer and Thorne, 2013). Figure 12 shows an example of the difference between a post-restoration reach and a pre-restoration reach.

Figure 14: Snapshots of the channel from a post-restoration reach (left) and a pre-restoration reach (right).
