Upper Deschutes River Bank Stability Characterization

August 2002

Kolleen Yake, Watershed Assessment Manager, Upper Deschutes Watershed Council
PO Box 1812, Bend Oregon 97709

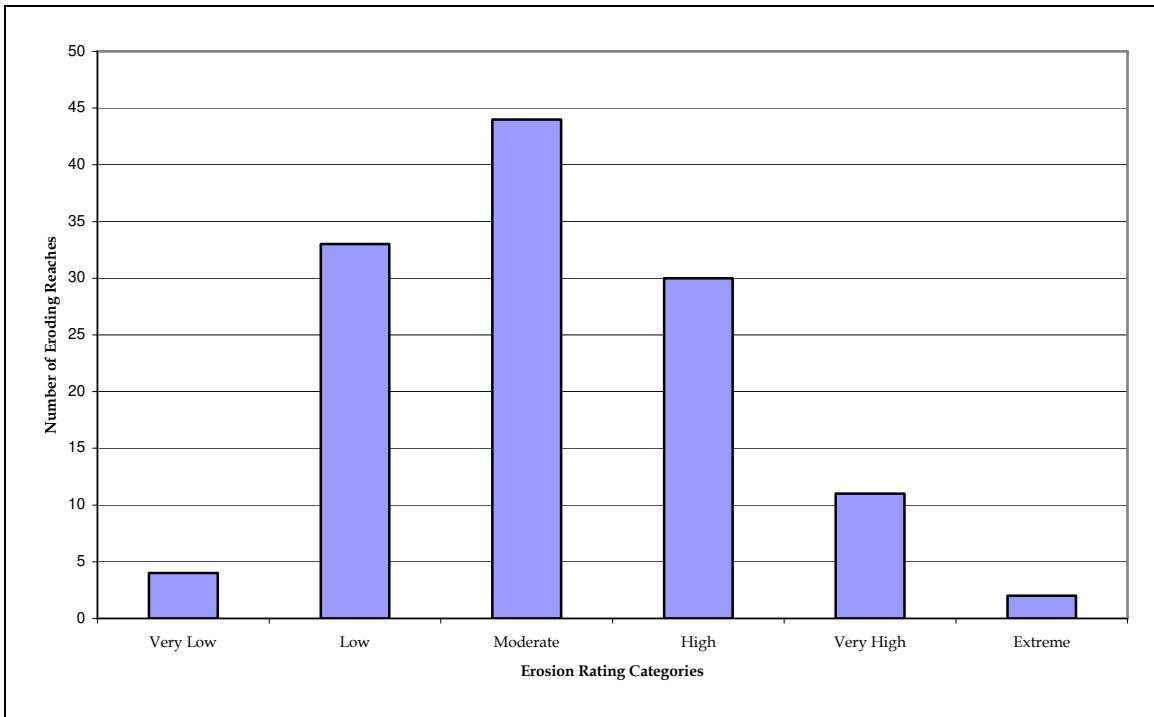
Figure 2: Streambank Erosion Ratings for the Upper Deschutes River

The data for the BEHI values of each stream reach assessed are presented at the end of this document in Table 4. Next to each stream bank condition value is the corresponding index value from the BEHI ranking system presented in Table 3. Of the 130 reaches assessed, 2 were rated as extreme, 13 were rated as very high, 32 were rated high, 45 received moderate ratings, 37 were rated low, and 6 were rated very low. Figure 2 presents a graphical comparison of the eroded stream reaches. The digital photos taken of each stream reach are located on the compact disc included with this report. The physical locations for each stream reach are depicted in the Upper Deschutes River Bank Stability Characterization Map book.

The results indicate that 47 reaches on the Upper Deschutes are currently eroding at high, very high, or extreme rates. Analysis of the methodology for assessing the bank heights of stream sections has revealed that there may in fact be a greater number of high, very high, and extreme banks than the study indicates due to the fact that bank height and surface protection were both measured to the very top of the bank instead of to the top of the eroding portion of the bank. Therefore, it might appear that there is a greater percentage of surface cover protecting the bank from eroding than currently exists.
