Rehabilitating Valley Floors to a Stage 0 Condition: A Synthesis of Opening Outcomes

This article was submitted to
Freshwater Science,
a section of the journal
Frontiers in Environmental Science

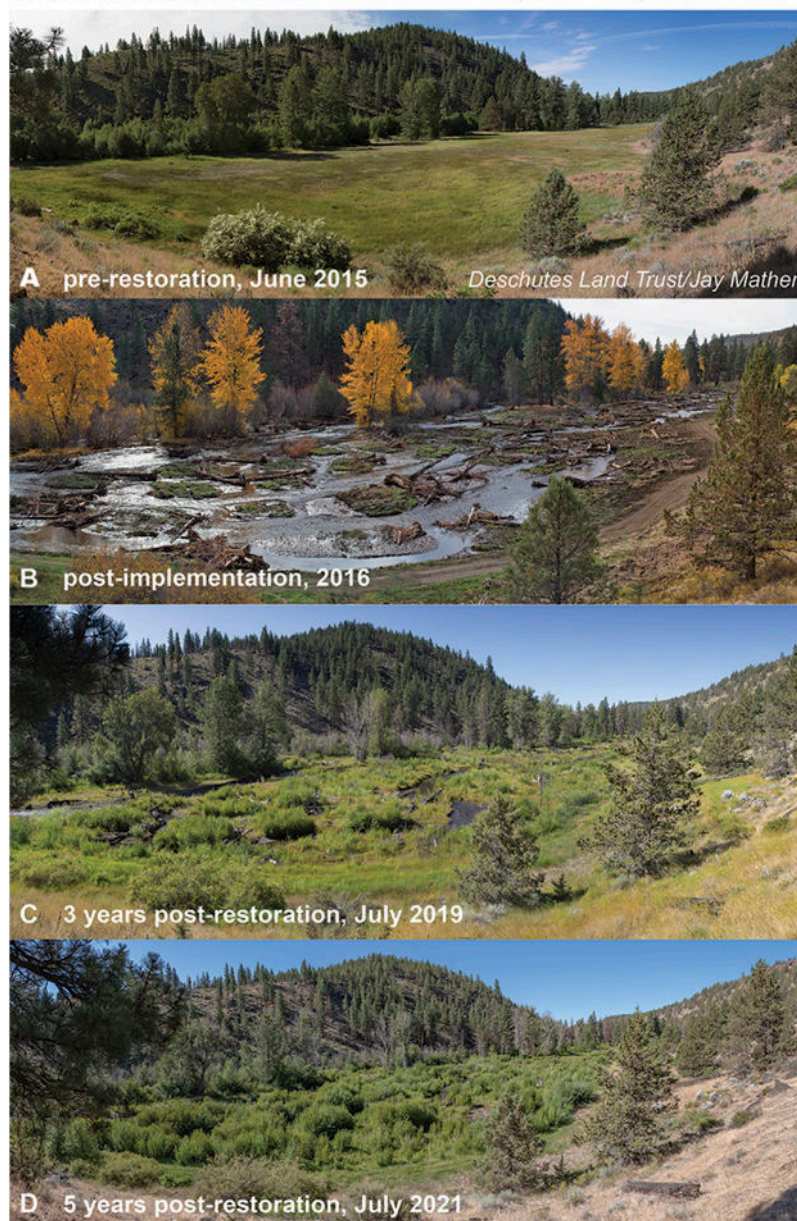
FIGURE 1 | At Whychus Creek, at the Whychus Canyon Preserve, restoration to a stage 0 condition was implemented and documented with photos of: **(A)** pre-restoration condition; **(B)** immediately post implementation condition; **(C)** 3 years post restoration, and; **(D)** 5 years post restoration.

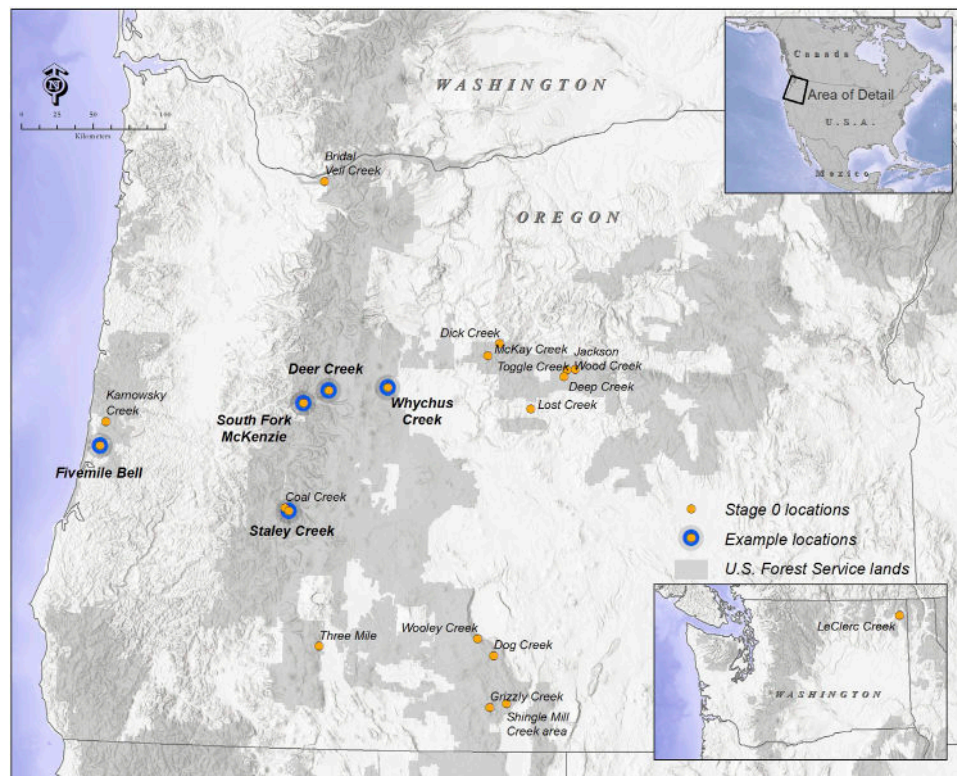
FIGURE 2 | Restoration projects targeting a Stage 0 condition were identified in the Pacific Northwest, United States, and primarily in Oregon. Projects were identified based on project goals to restore/reconnect rivers to their floodplain at a valley scale allowing for the development of longitudinal, lateral, and vertical hydrologic connectivity.

Stream restoration practitioners identified over 20 sites where process-based, valley-scale intervention was intended to restore dynamic river systems (Figure 2). Some of these projects were completed before the advent of the term “Stage 0”. Recent projects are that larger in spatial extent tended to have more focused

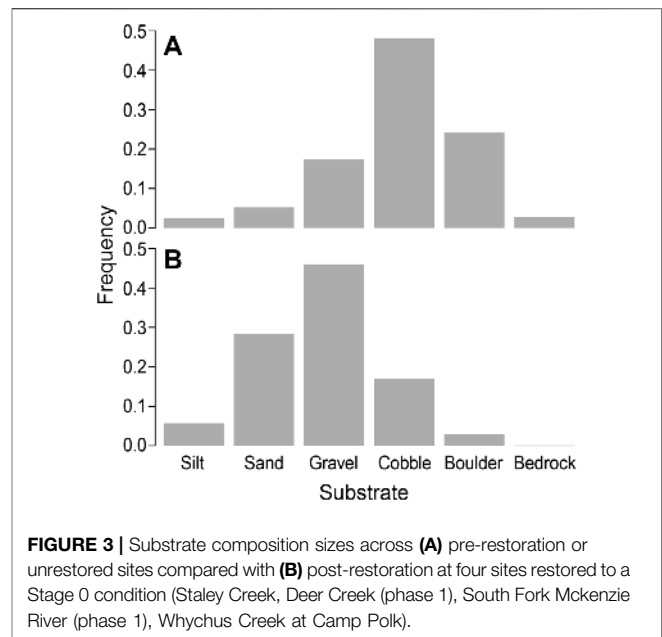
FIGURE 3 | Substrate composition sizes across (A) pre-restoration or unrestored sites compared with (B) post-restoration at four sites restored to a Stage 0 condition (Staley Creek, Deer Creek (phase 1), South Fork Mckenzie River (phase 1), Whychus Creek at Camp Polk).

toward finer particle sizes was observed across four sites monitored for stream substrate. Across all sites, larger particles present before restoration were replaced with smaller size classes that are more conducive to salmon (Riebe et al., 2014) and lamprey spawning (Hogg et al., 2014). The shift in substrate size likely reflects both the mechanical reorganization of material during restoration, as well as fluvial deposition and sorting of finer particles over time as the restored reach became a slower-water, depositional environment (for relevant sedimentation and fluvial processes see Hudson, 2017). Additional monitoring to document changes in sediment and wood distribution, and resulting effects on available aquatic habitat complexity will elucidate how placed and subsequently rearranged materials alter stream habitats for native biota including fish. Notably, long-term monitoring of wood transport distance in hydraulically rough, multi-channel, Stage 0 systems will help inform both the potential for long-term benefits from placed wood and the effects of restoration to Stage 0 on the wood regime.

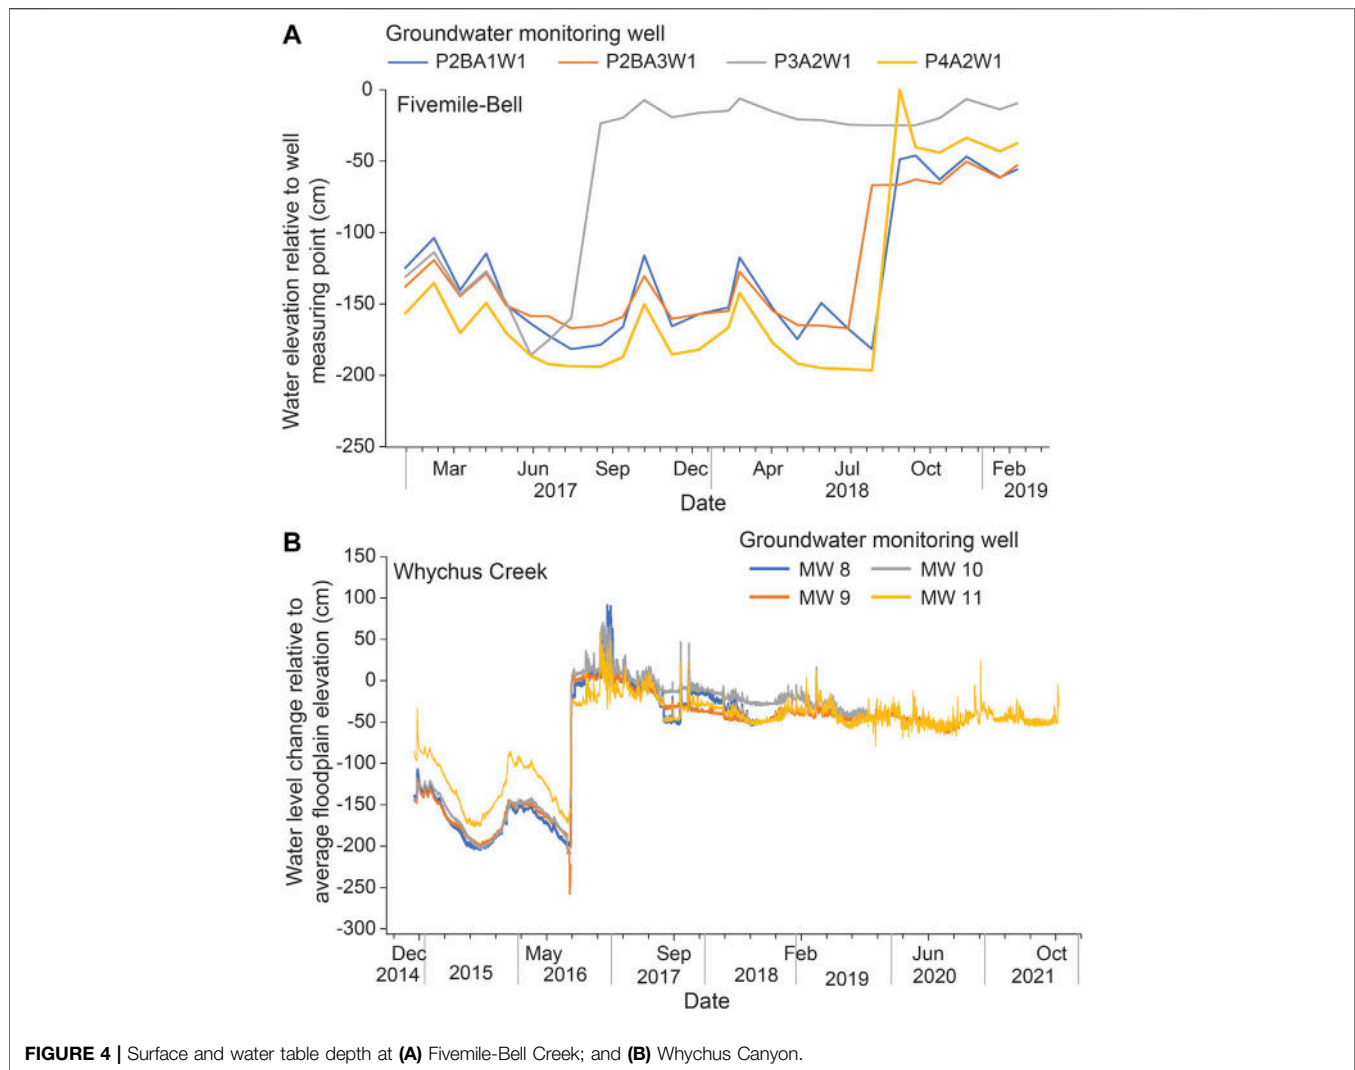
FIGURE 4 | Surface and water table depth at **(A)** Fivemile-Bell Creek; and **(B)** Whychus Canyon.

At WCPreserve Phase 1, maximum groundwater depths pre-restoration occurred in August, ranging from -2.5 m to -1.7 m. Minimum groundwater depths occurred between late December and mid-February, at -1.2 m to -0.3 m. Maximum groundwater depths post-restoration occurred between late July and mid-September, ranging from -0.6 m to -0.1 m. In contrast to pre-restoration conditions, these post-implementation groundwater levels are within the range needed to support hydrophytic

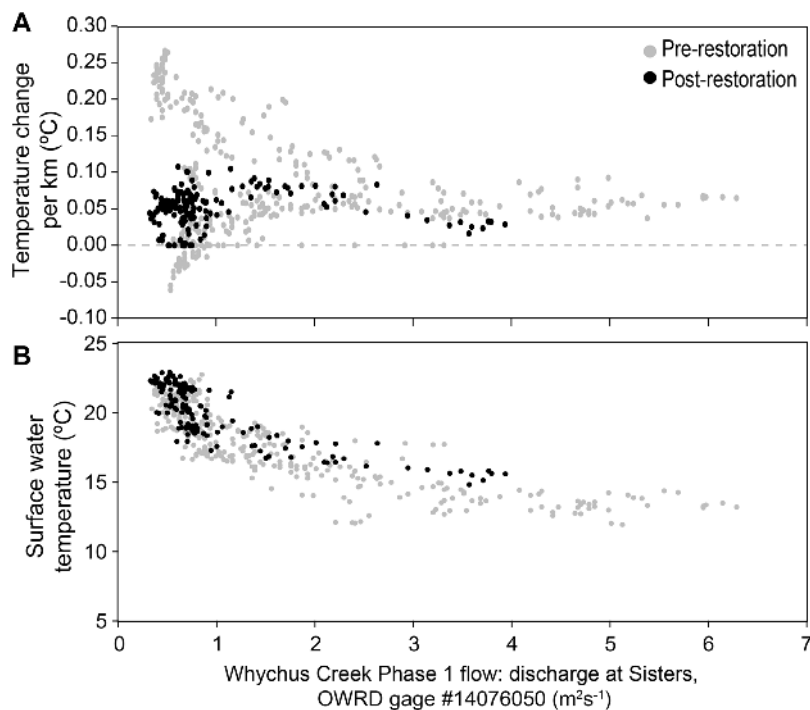
FIGURE 5 | Water temperature pre- and post-restoration to a Stage 0 condition at Whychus Creek at Whychus Canyon: **(A)** rate of change per kilometer, and; **(B)** surface temperature (°C).

At the WCPreserve Phase 1 site, higher variability in thermal change per kilometer was apparent at low-flows pre-restoration (-0.07° – $0.26^{\circ}\text{C km}^{-1}$), while the rate of change at all flows post-restoration remained relatively steady (0 – $0.13^{\circ}\text{C km}^{-1}$). Rate of change at higher flows appeared lower post-restoration than pre-restoration (Figure 5A). July surface temperature remained within the same range of variation present in the pre-restoration data (Figure 5B).

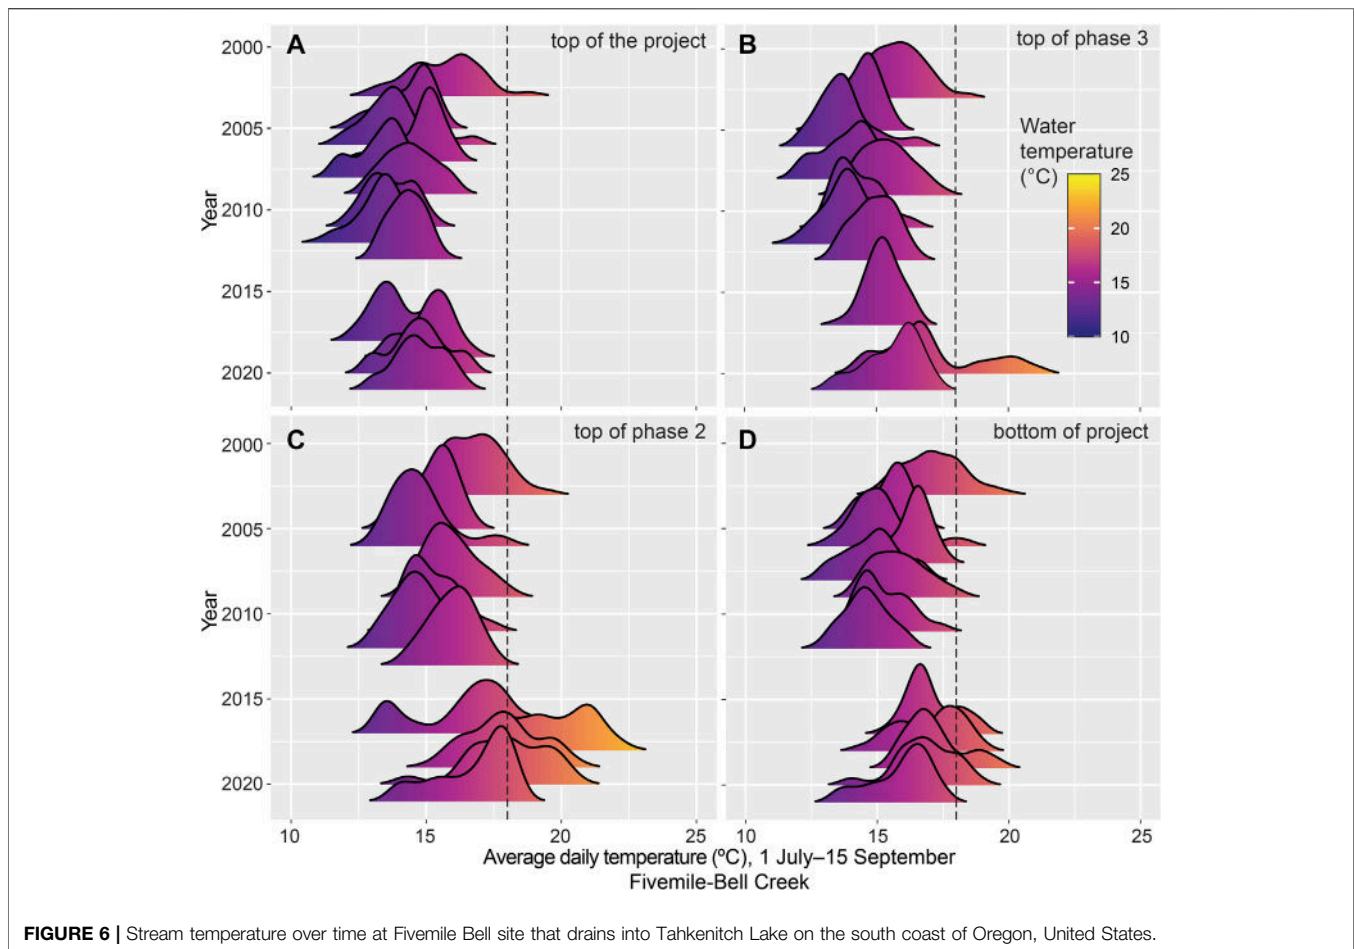
At Fivemile-Bell, the lowest temperature observed was 5.79°C in November 2007. Minimum temperatures across all sites typically occurred between October and December (5.79 – 10.58°C). From 2003 through 2013, maximum temperatures occurred from July through September (16.33 – 18.52°C), with an outlier extreme of 20.1°C in July 2003. Post-restoration maximum temperatures ranged from 20.75 to 29.92°C . However, daily average temperatures did not exceed 23°C during the same time period (Figure 6C). Despite the

initial temperature increase following restoration activities, the distribution of daily average temperatures began to trend cooler in subsequent years (**Supplementary Figure S1-3**).

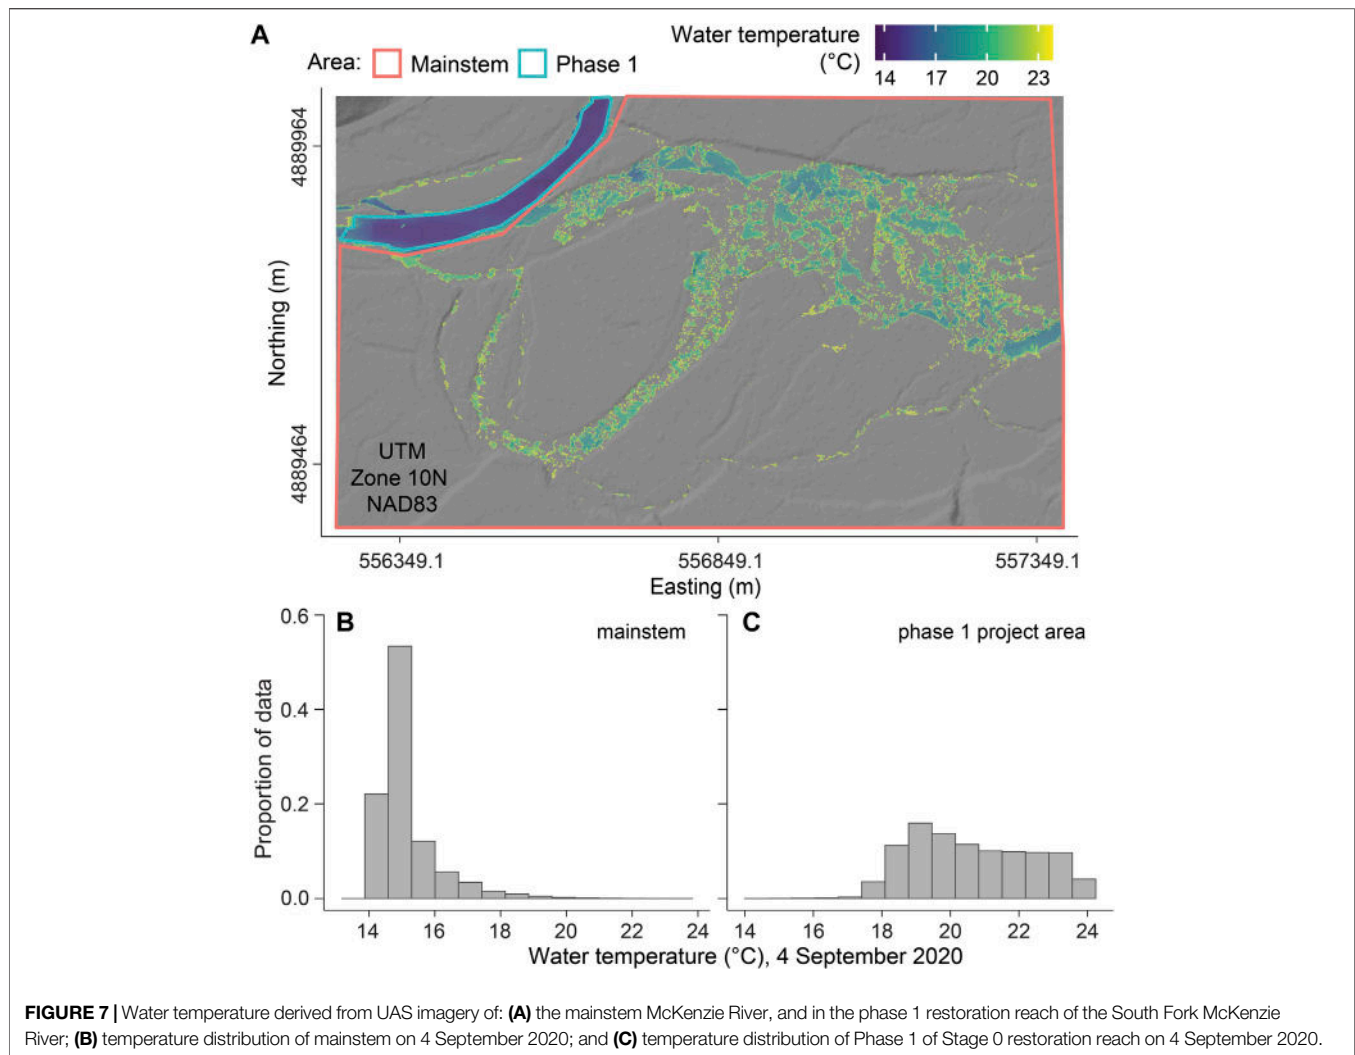
The thermal imagery (**Figures 7A–C**) shows temperatures from 4 September 2020 surveyed between 1:46 to 3:18 p.m. PDT, with average water temperatures at the USGS gage of 13.88°C. Based on the rate of heating with distance, the expected pre-restoration average water temperature would have been 15.82°C. In contrast, no point location on the thermal imagery was colder than 14.0°C (**Figure 7C**; **Supplementary Table S3-4**), and the median temperature of the surface of the water was 20.4°C. The imagery (**Figure 7A**) also shows higher spatial variation in temperatures in the restored SFMR than in the mainstem McKenzie River. The surface temperature of the mainstem had a standard deviation of 0.9°C and a range of 4.2°C (**Supplementary Table S3-4**), with visibly warmer water evident along channel edges and a patch west of the Phase 1 outlet. Phase 1 appears more heterogeneous, having surface temperature standard deviation of 1.6°C and a range of 6.1°C (**Supplementary Table S3-4**), with warmer water present near accumulated woody material and the stream edge. These

differences are clearly shown in the width and shape of the frequency distributions of the surface water temperatures (**Figure 7B** vs **Figure 7C**).

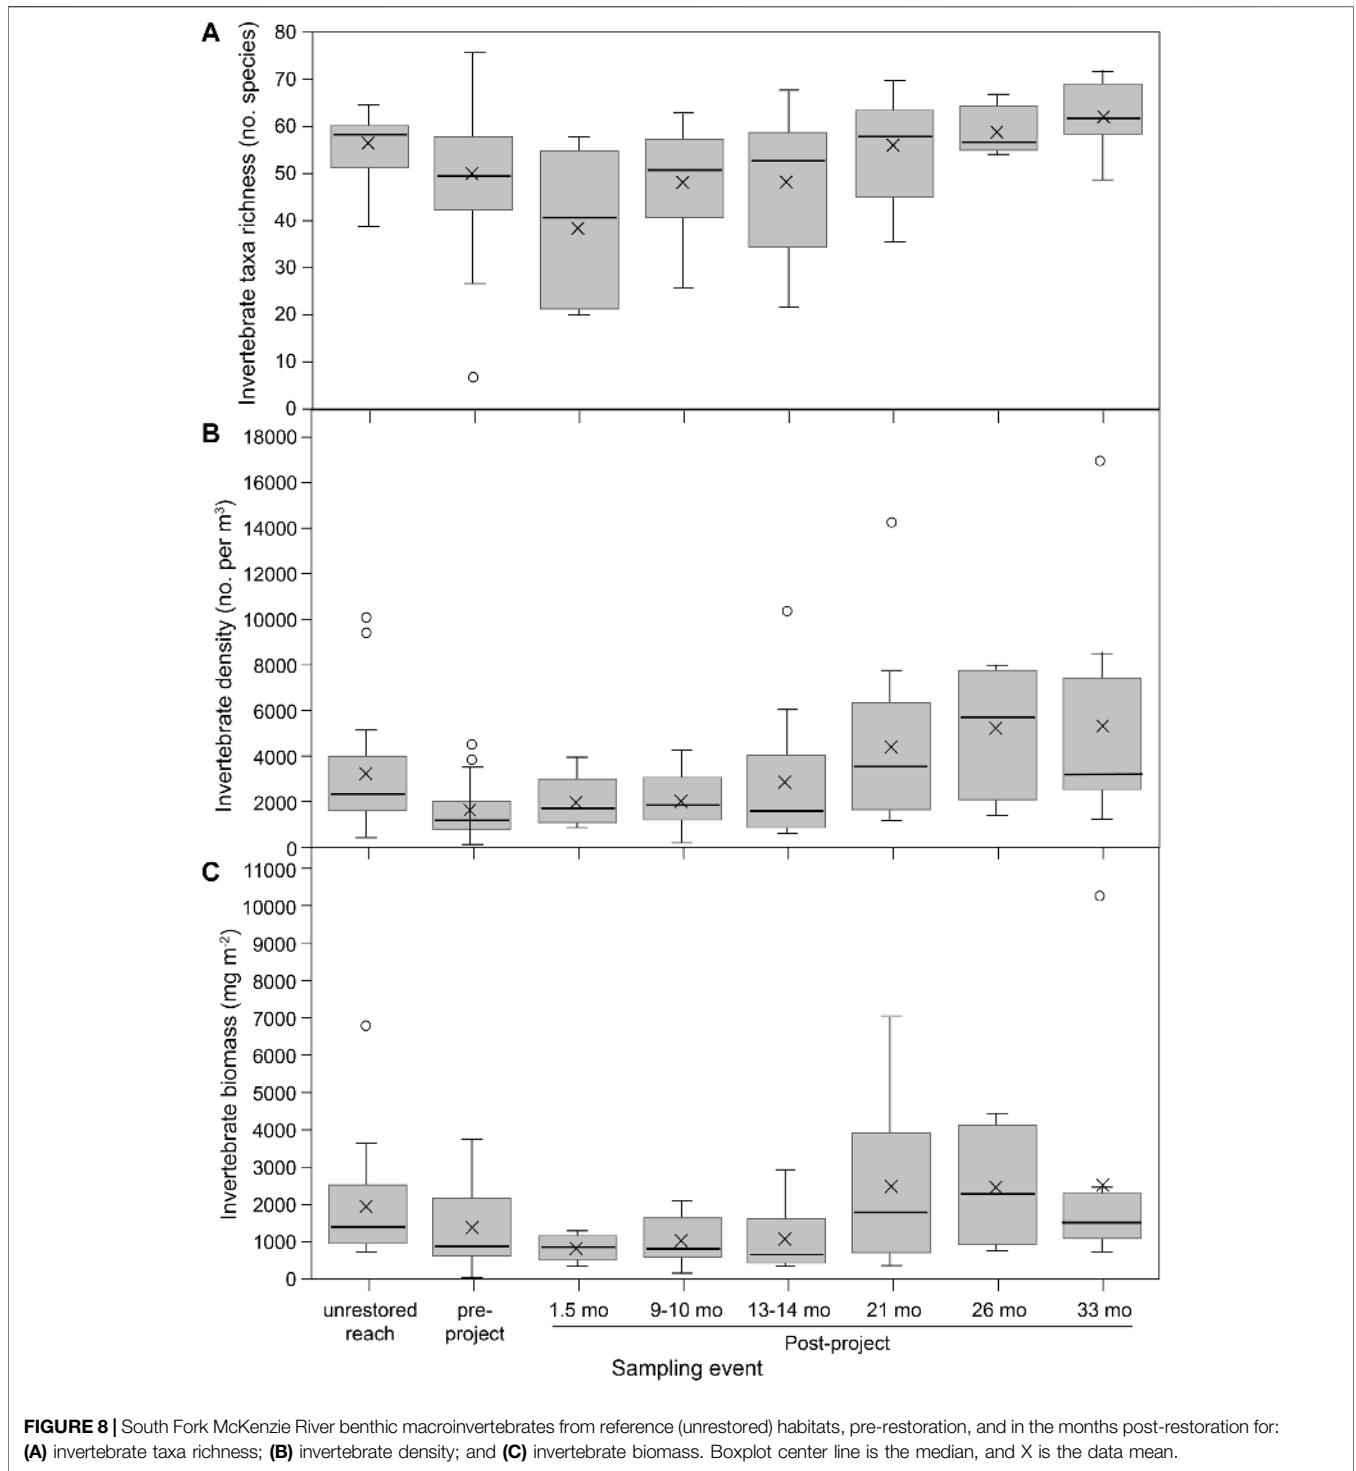
Generally, similar values of aquatic macroinvertebrate richness, abundance, and biomass were found among pre-restoration, post-restoration, and unrestored sites in the SFMR (**Figures 8A–C**). Invertebrate richness and biomass were not significantly different pre-restoration, whereas density was significantly lower (**Supplementary Table S4-2**). However, all metrics increased over time following restoration (**Supplementary Table S4-2**). Samples collected approximately the first year after restoration (1.5–14 months) have richness, density, and biomass values within the range of pre-restoration. Samples collected approximately 2–3 years after restoration (21–33 months) have higher values compared to pre-restoration, but within the range of unrestored samples. Comparisons of overall taxa richness, density, and

biomass did not account for changes in assemblage compositions. That said, qualitative differences in community assemblages were observed. The snail *Juga* (*Juga hemphilli maupinensis*), for instance, comprised an average of 22 and 24% of the biomass in unrestored and pre-restoration samples, but only 5% of the biomass post-restoration.

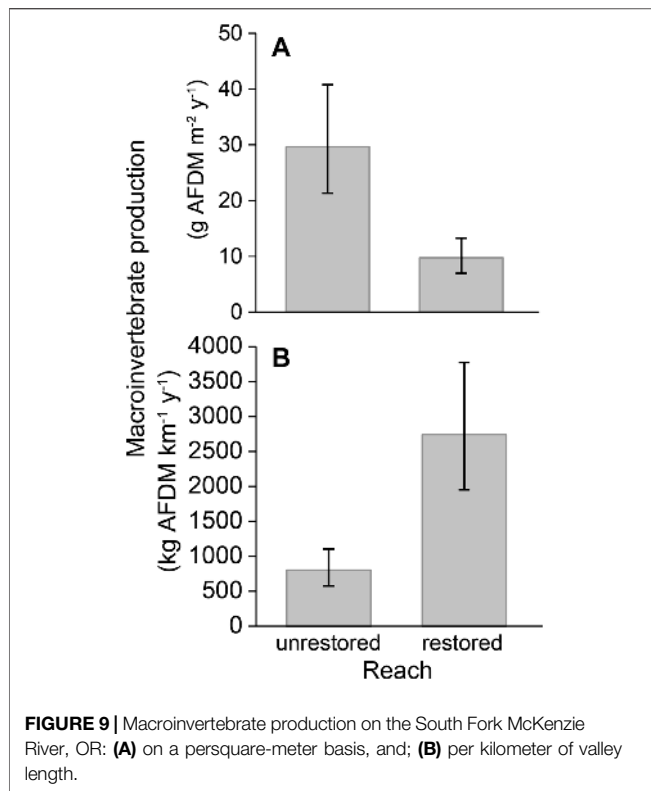
Secondary macroinvertebrate production in the restored reach of the SFMR was lower than unrestored reaches on a per-square-meter basis from July 2019 to July 2020 (9.8 g AFDM $\text{m}^{-2} \text{y}^{-1}$ in unrestored vs. 29.6 g $\text{m}^{-2} \text{y}^{-1}$ in restored, on average (**Figure 9A**; Jennings 2021). However, when scaled to the greater area of wetted habitat available (**Supplementary Table S4-1**), the restored reach had $\sim 3\times$ as much macroinvertebrate production. Per kilometer of valley length, the restored reach produced 2,750 kg (AFDM $\text{km}^{-1} \text{yr}^{-1}$) over the year, whereas unrestored reaches supported only 802.3 kg of macroinvertebrate production (**Figure 9B**).

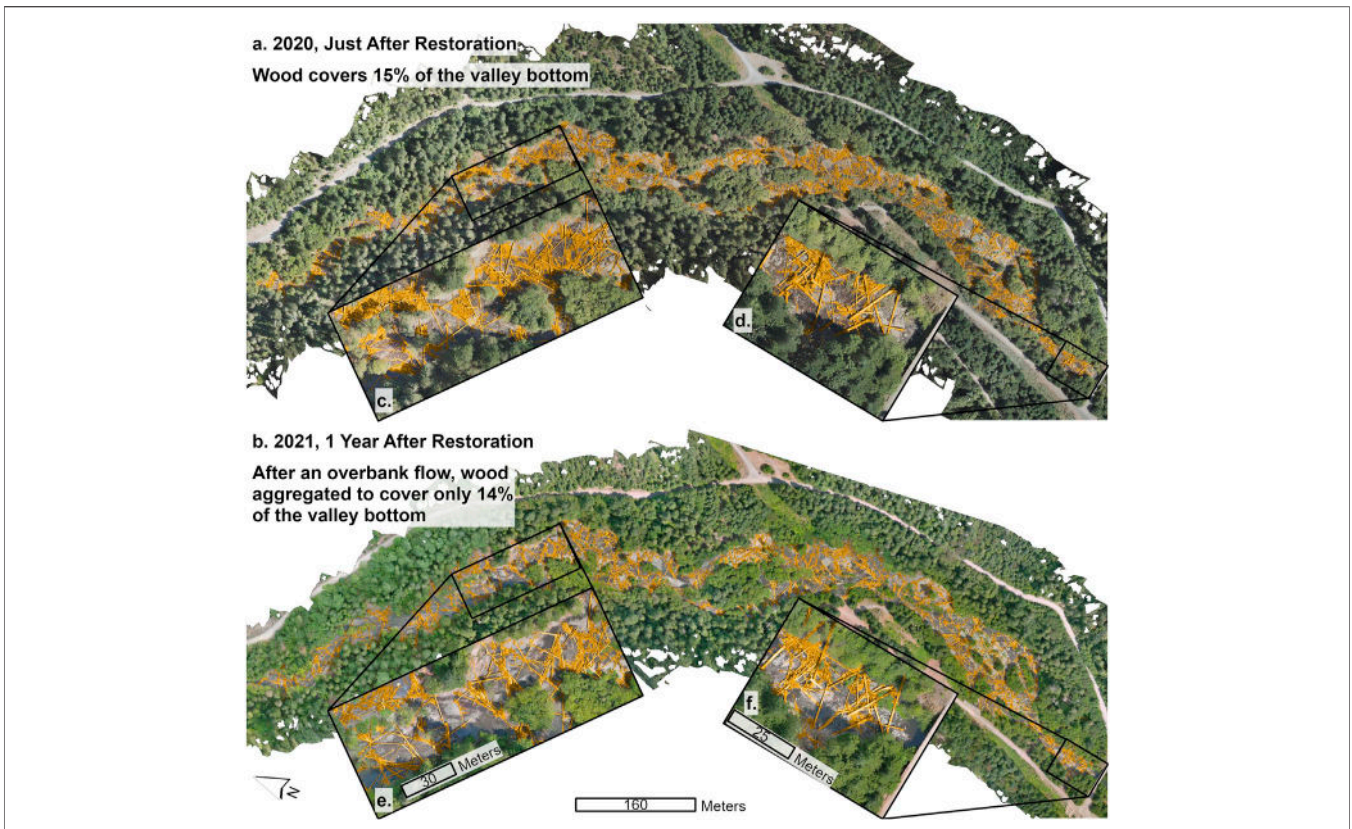
FIGURE 11 | Wood (colored in yellow) on the valley floor of the Deer Creek, Oregon site: **(A)** shortly after restoration was completed; **(B)** 1 year post-restoration; **(c,d)** insets showing placement of wood latices; and **(e,f)** insets of parallel locations showing accumulation of wood material after overbank flow events of the winter months.

This post-restoration high-flow event, and the wood aggregation it caused, resulted in a loss of wood coverage from 15 to 14% of the valley bottom area. However, this reduction in coverage was likely due to aggregation, not the export of wood from the project site. We infer this based on observations that the jam at the downstream end of the reach is taller than the flood-flow depth and did not move substantially during the flood or noticeably lose wood (compare Figure 11D with Figure 11F). This jam likely caught any wood that made it near the downstream end of the reach, preventing downstream mobilization.

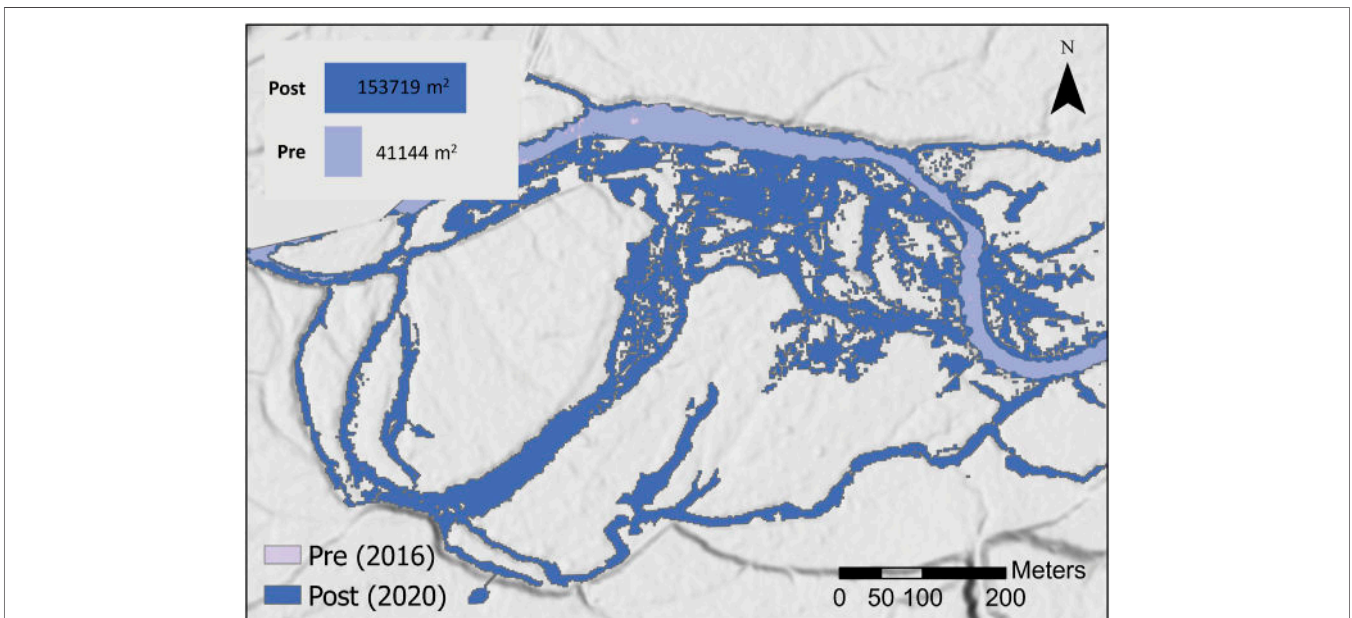
FIGURE 12 | Inundated area comparison pre- and post-restoration to a Stage 0 condition at the South Fork McKenzie River, OR. Visual overlay of the pre-treatment wetted area, based on early-summer 2016 imagery, compared to post-treatment wetted area, based on late-summer base-flow imagery. The background image is the LIDAR-derived DEM from 2020. Prior to restoration, the channel occupied only 41,114 m² of area, as depicted on the northern edge of the image. In contrast, the post-restoration channel occupies not only a greater area, approximately 153,719 m², but encompasses a landscape of over 400,000 m² in area.

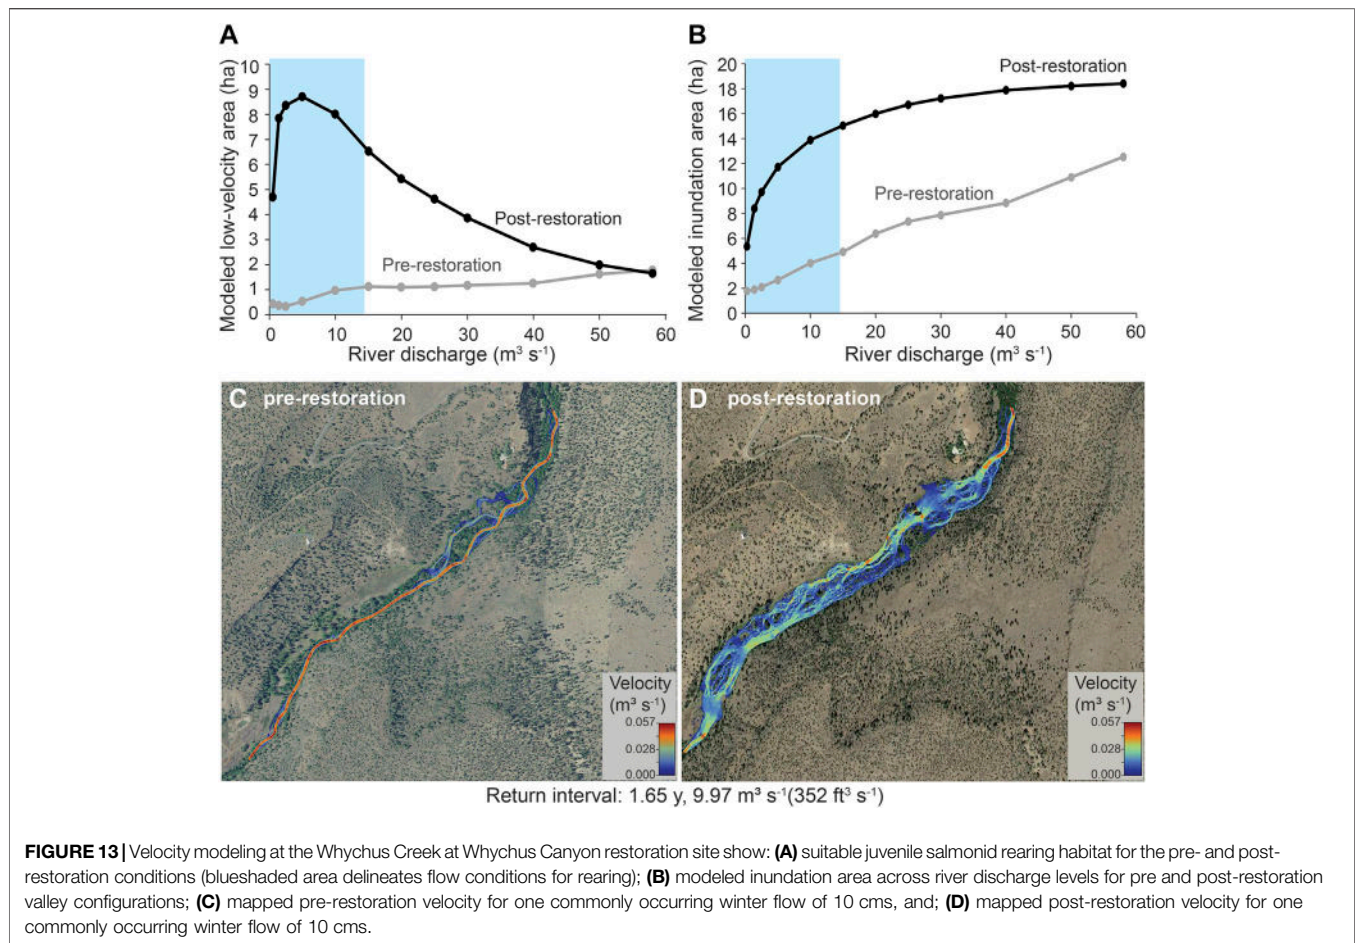
Model results of velocity patterns from the restoration of WCPreserve Phase 1 to a Stage 0 condition showed substantially increased low-velocity habitat suitable for rearing juvenile salmonids over a broad range of discharge (Figure 13A). Suitable rearing habitat is plotted over the range from summer base-flow to the 100-years event (Figure 13A). Pre-restoration juvenile rearing habitat was low overall and decreased to minimum values when common winter and spring storm flows occurred (Figure 13C), evidence of potential for juveniles to be flushed downstream by these events. In the post-restoration environment, the suitable rearing habitat

increased substantially and reached maximum values up to 27 times greater during juvenile rearing flows (**Figures 13A,D**). The two curves converge at the highest flows (e.g., Q100) because the narrow floodplain is confined between steep canyon walls and is filled to capacity (**Figure 13A**).
